HVDC INTERFERENCE ON MGL PIPELINE

HVDC Substation –

Effect on MGL Pipeline

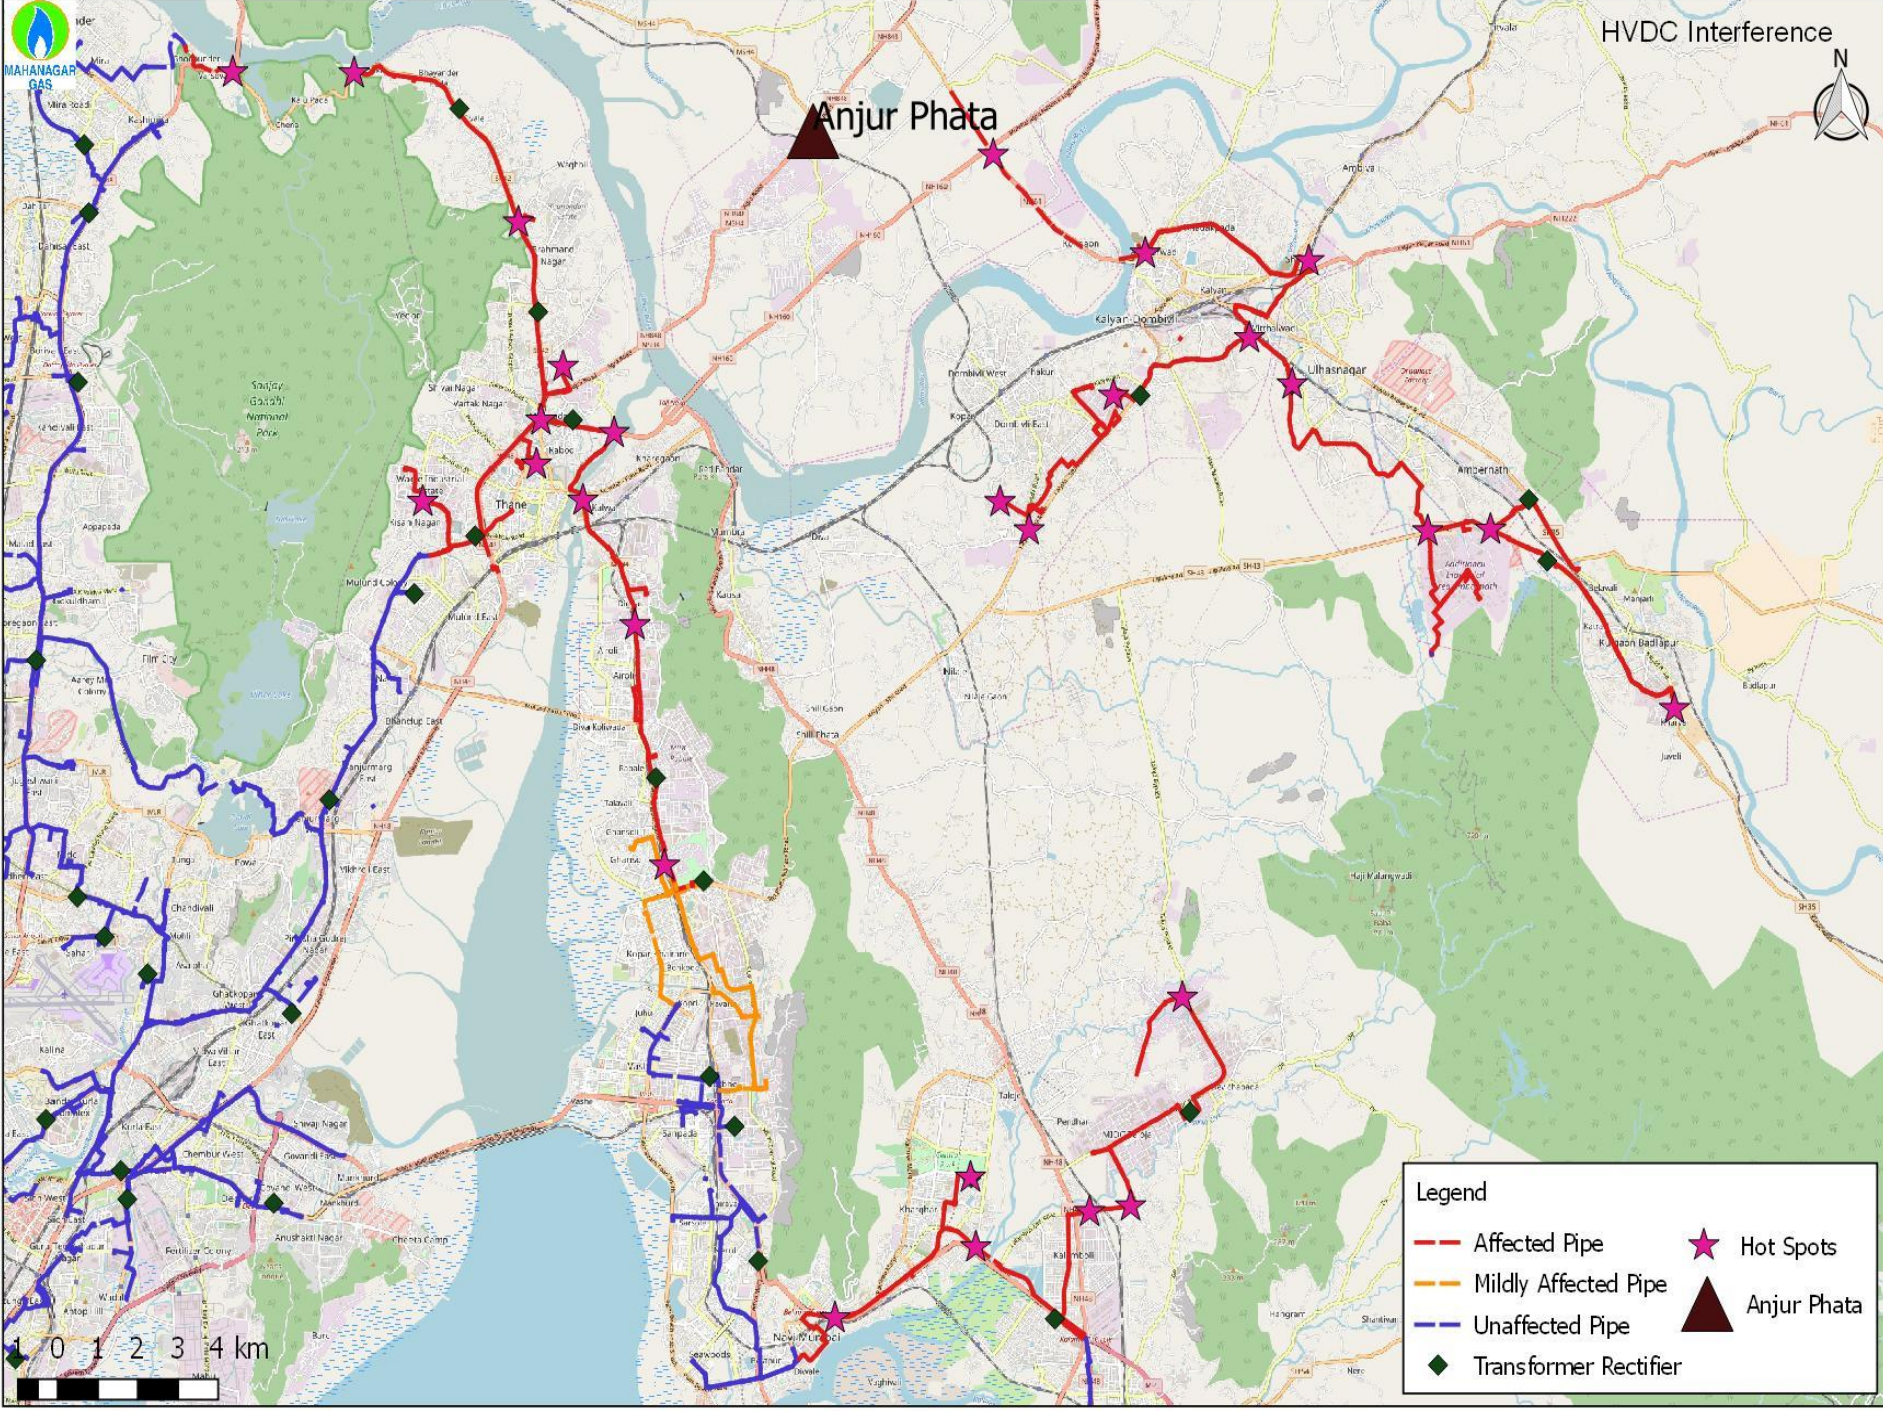
HVDC Interference

- ❖ Affected MGL Pipeline – 145 kms
- ❖ Maximum pickup : -2.4 Vdc (Ambernath).....Without TR
Maximum Discharge : + 1.2 Vdc (Thane).....Without TR
- ❖ Expected PSP : -0.44 Vdc (Natural Potential of Steel)
- ❖ Pickup and discharge swapped when polarity got reversed
- ❖ Insulating joints became hotspots for interference
- ❖ Oldest affected pipeline is laid in 2005
- ❖ Went unnoticed due to DC traction interference

- Affected Pipe
- Mildly Affected Pipe
- Unaffected Pipe
- Transformer Rectifier
- Hot Spots
- Anjur Phata

- Bonding of Insulating Joints
- Pickup locations – Grounding mechanism to be installed
- Discharge locations – Additional TR units to be installed
- Thickness testing wherever possible
- Remote Monitoring inside TLPs at pickup and discharge
- Coating defect rectification
- Survey results to be jointly discussed with MSETCL; Next meeting in Jan'19
