Steel NG Pipeline Repair due to External Damage

Case Study : 4'' Pipeline Damage

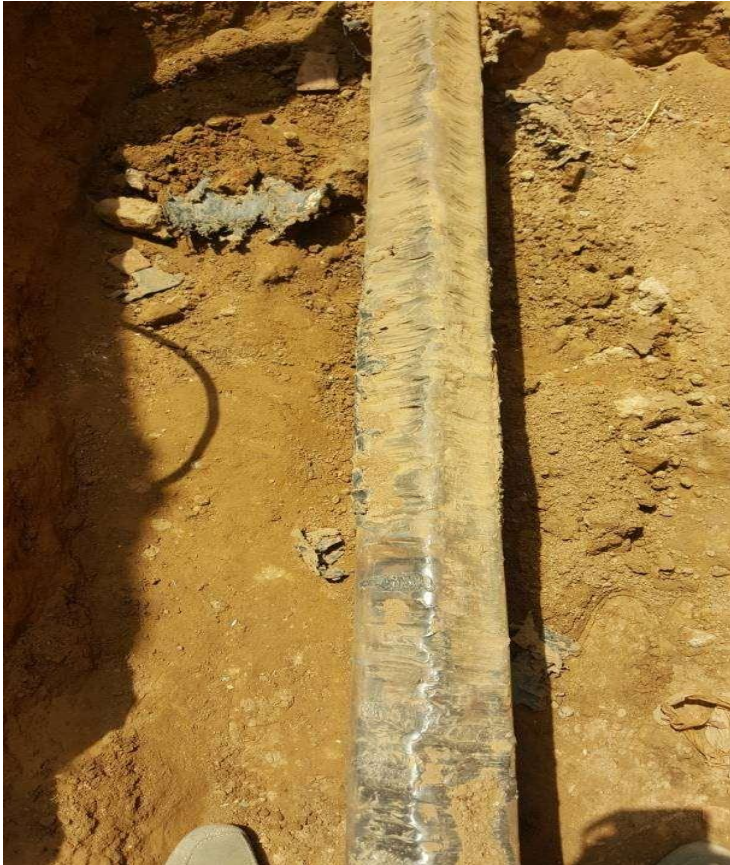
- Heavy leakage reported
- Pilot and reamer located
- Leakage from 2.5 mm patch observed
- On interrogation it was found that about 100 meter pipeline is damaged.

Pipeline
damaged
surface

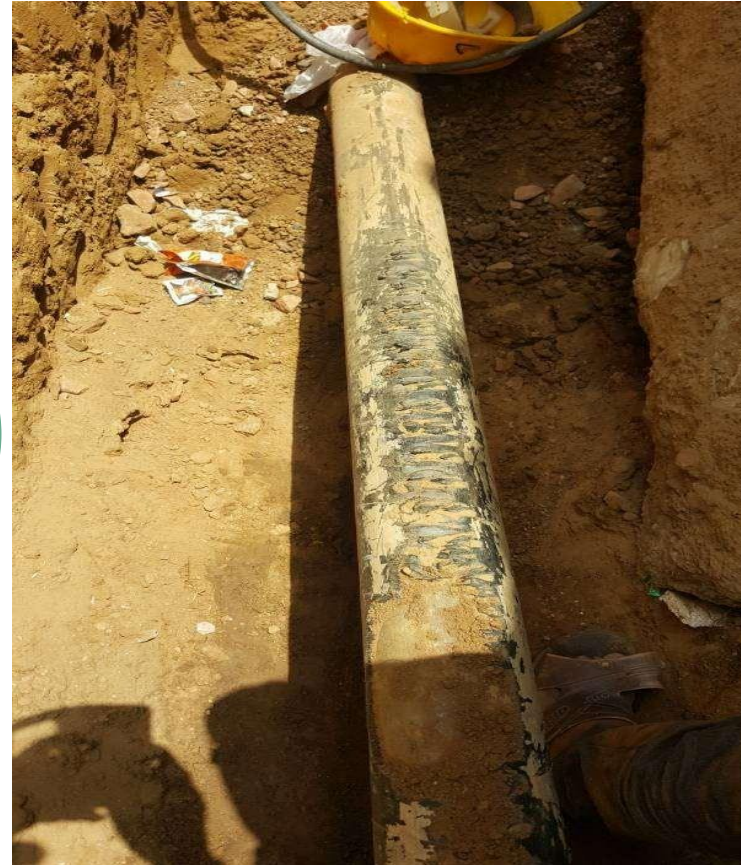
Damaged location

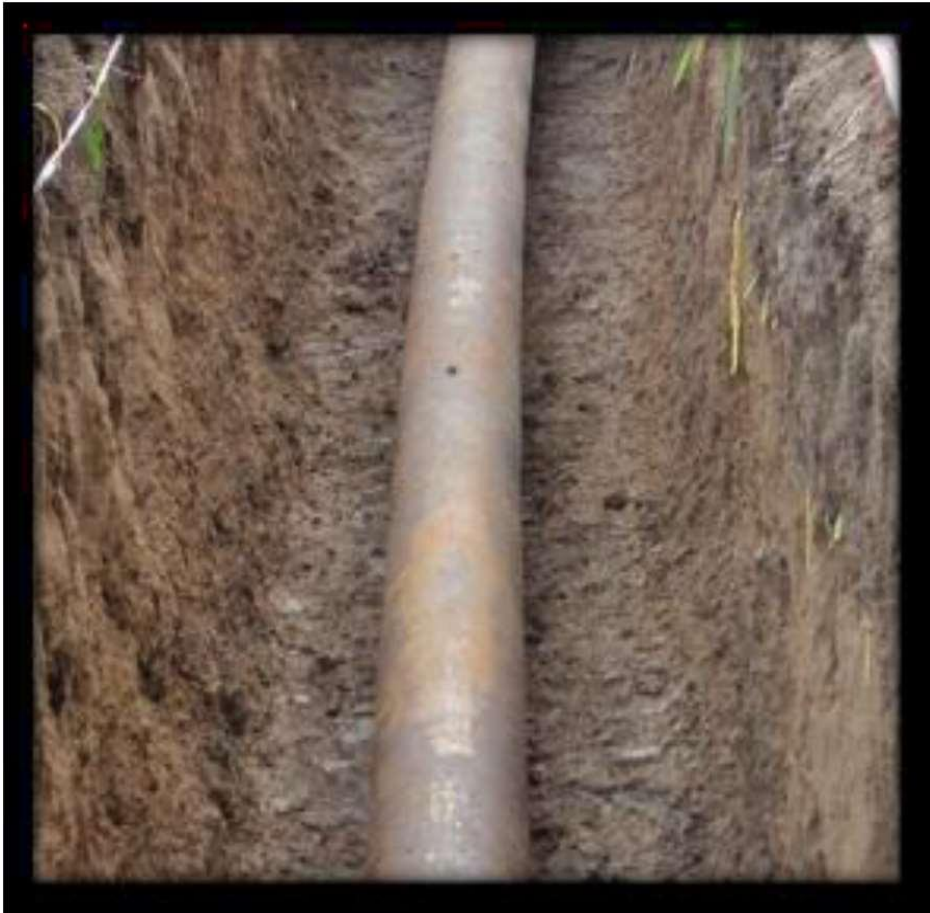
Before

- ✓ The damage caused to the pipeline was severe and shape was distorted, extra care was taken at the time of filler application
- ✓ Protection of R4D repair was crucial before curing, as the site was on highway with high probability of trespassing

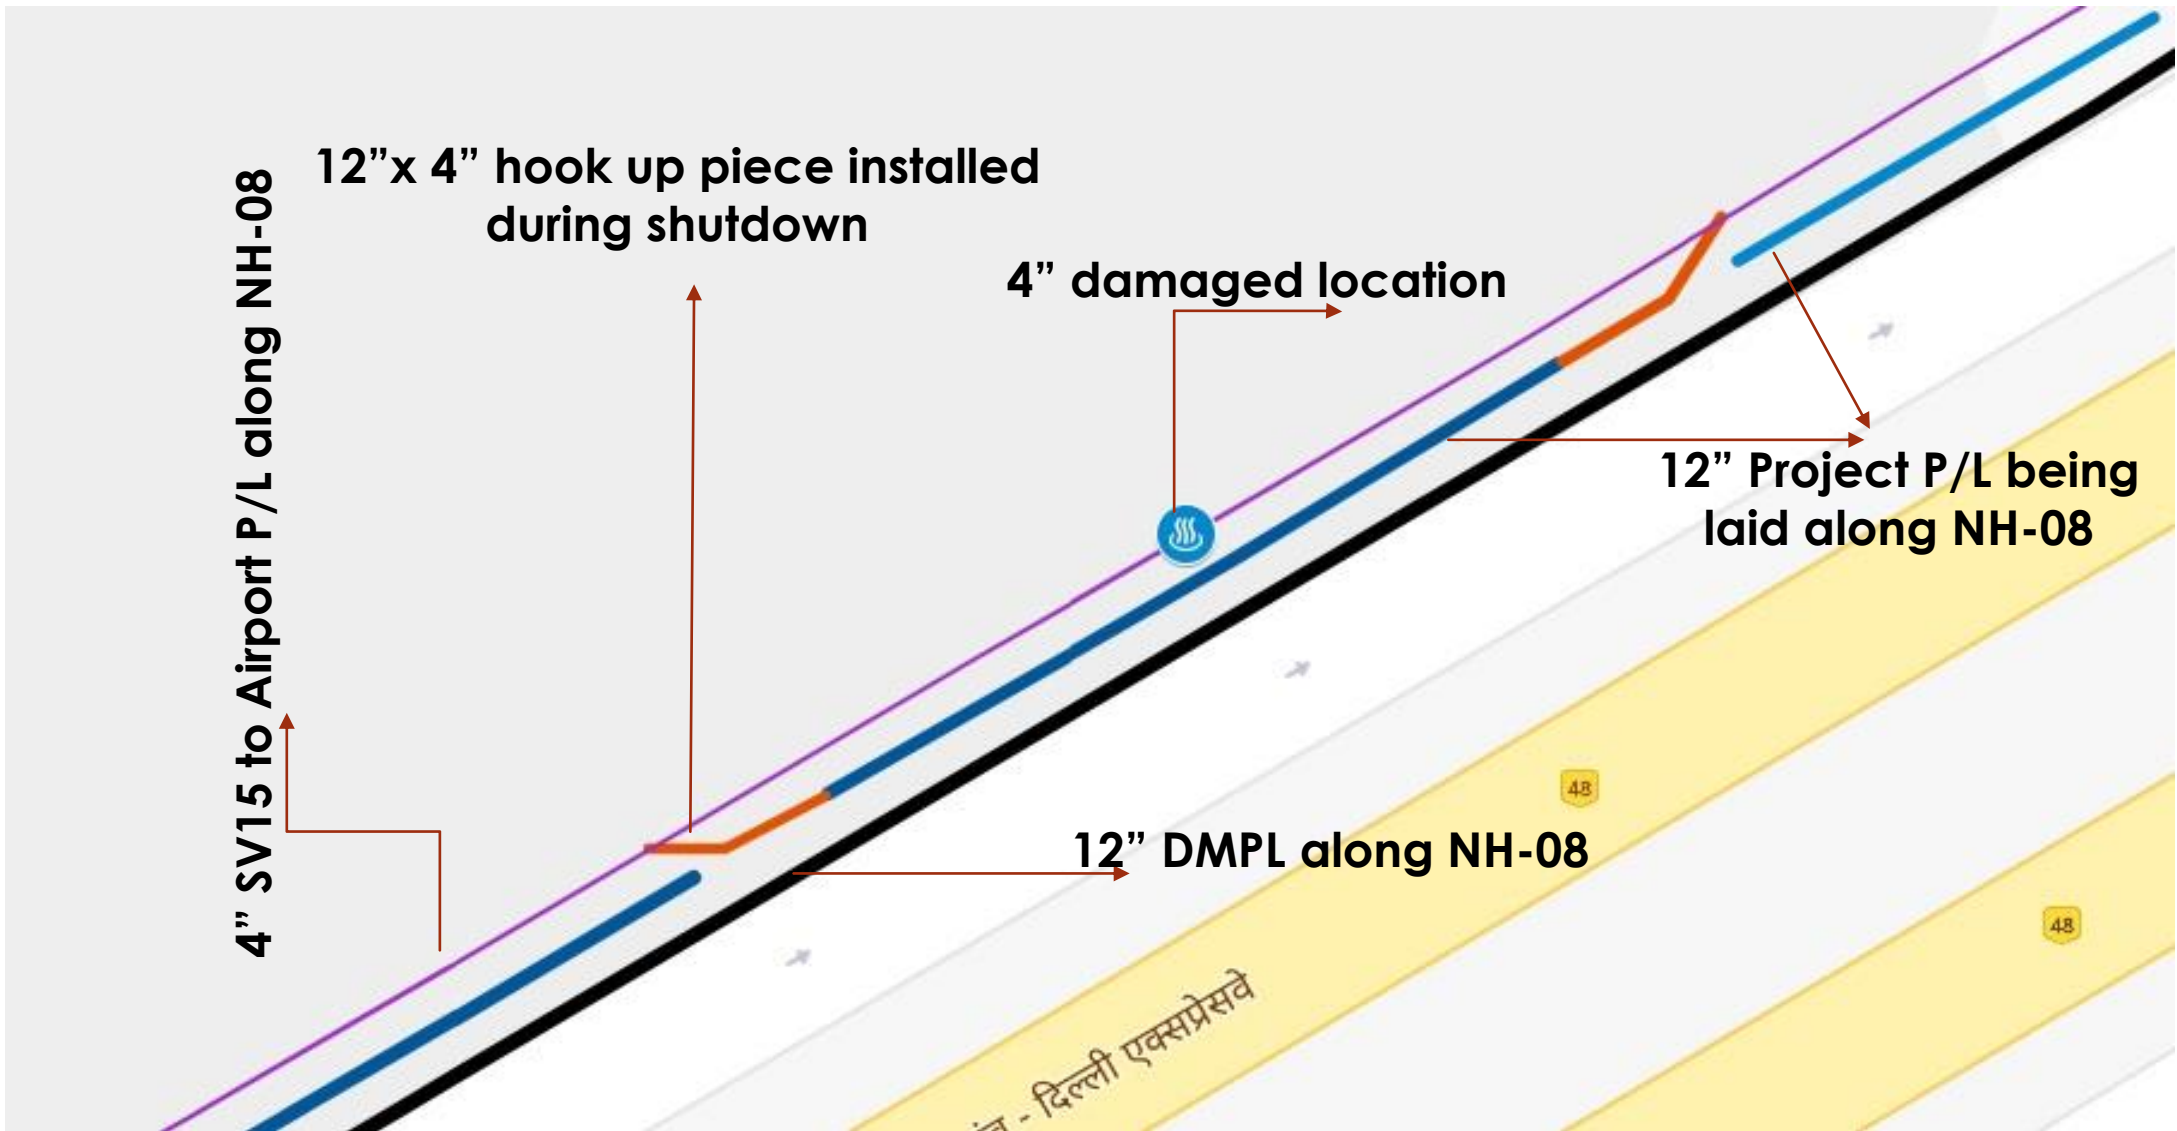
4" damaged location

New Pipeline laid after 25 Days of observation

12"x 4" hook up piece installed during shutdown
