Pipeline Infrastructure Limited

# Integrity Assessment of Non-Piggable Pipelines

28<sup>th</sup> June 2024

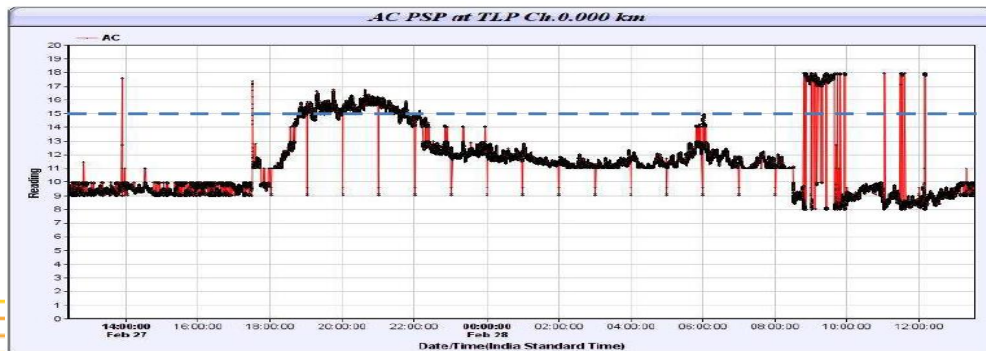
24 h data logging was carried out and AC PSP was seen to be reaching a maximum of 18 V during night time

AC current density was also calculated & found to be in the range of 1296 A/m<sup>2</sup>

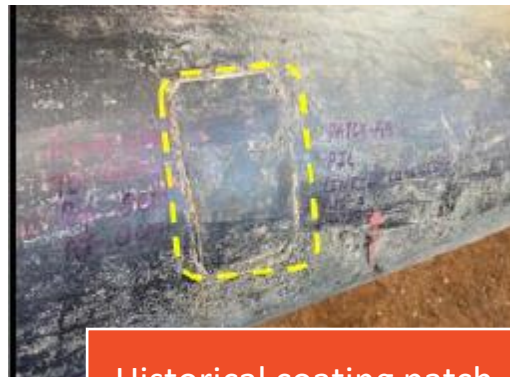
Historical coating patch

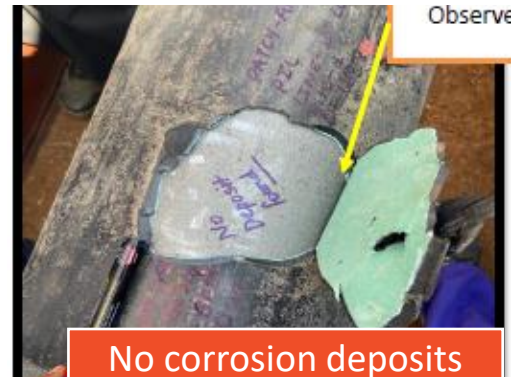
No corrosion deposits below the patch

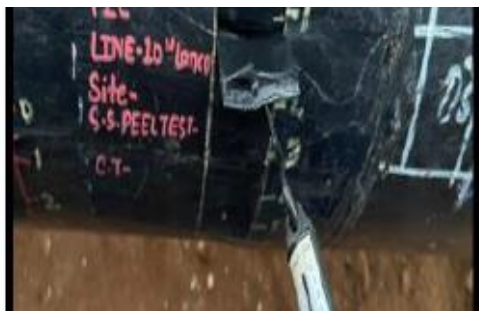
Peel test success on HSS

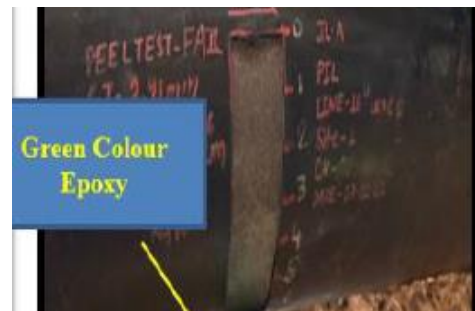
Peel test fail on 3LPE

- Epoxy thickness was seen to be 179  $\mu\text{m}$ . ISO 2808e specifies 200  $\mu\text{m}$
- Instant OFF PSP  $> -1.2$  V at certain points
- High AC PSP seen at some points which can lead to coating becoming electrically charged and break down leading to formation of bubbles causing disbondment
- Soil has alternate drying & wetting properties which can accelerate disbondment

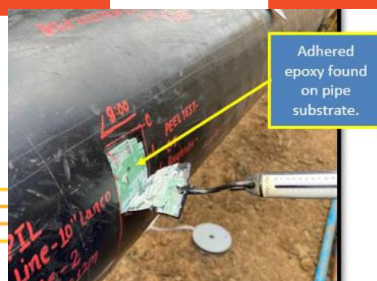
Adhered epoxy found on pipe substrate.

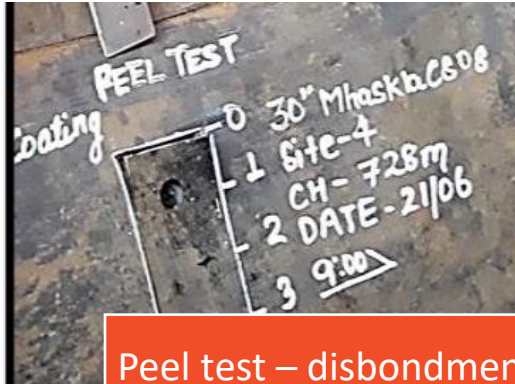
Peel test – disbondment

- (a) Coating system applied- HSS (100% disbondment)
- (b) External corrosion metal loss featured at both sites – 1 isolated pit at one site, 3 external corrosion anomalies.
- (c) Active AC corrosion phenomena

- (a) Instant Off  $> -1.0$  V with thin or no epoxy layer for 14 years

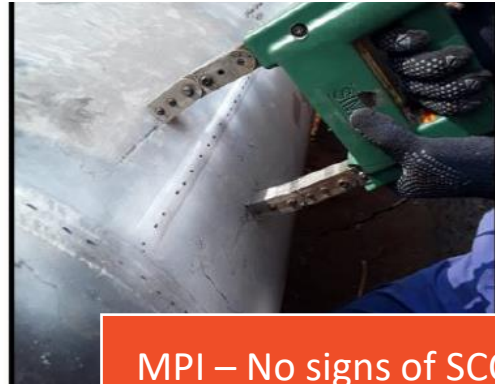
MPI – No signs of SCC

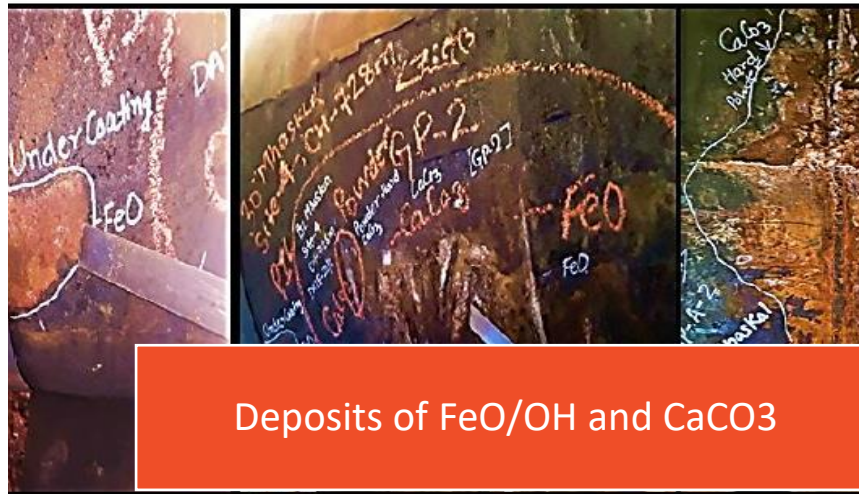
Deposits of FeO/OH and CaCO<sub>3</sub>
