Steel Pipeline Experience in MGL

08.01.2019

Case Study -Black Powder in Gas Pipeline Network

Case Study -Valve Failure

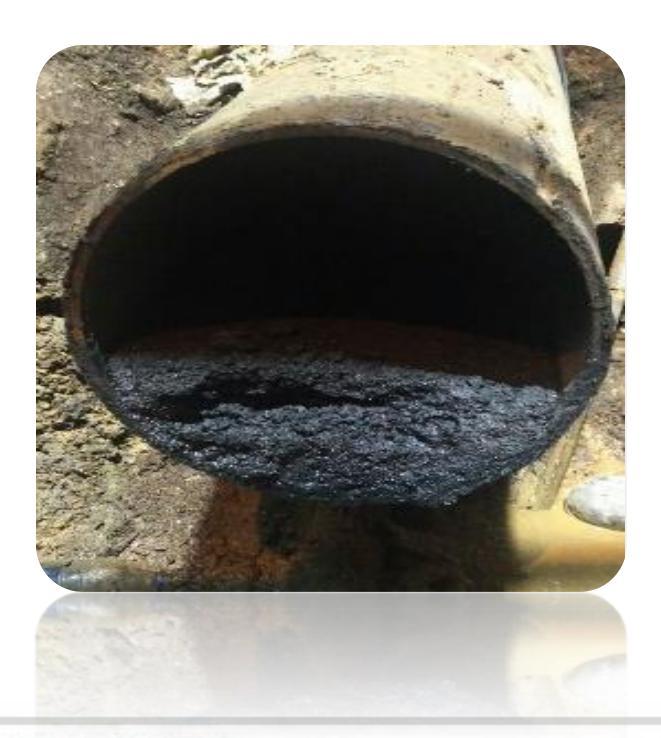
- Third Party Damage @ Malad (WEH)
- Piling activity in Metro work by MMRDA contractor
- Incident Date 29.03.2017.
- Pipeline cut & reweld
- During rectification, traces of Black powder observed

- Pipe size 12" NB, API 5L X 60, 6.4 mm Thick
- Pipeline protected with ICCP
- Year of construction 2000/01
- Depth of pipe at damage location 6.0 meter from road surface

- Engaged L&T Hydrocarbon Ltd (LTHL)
- Findings -
 - Particle type mostly Iron oxide
 - Particle Range 0.3 to 175 micron meter
 - Mostly 1-15 micron meter
- Recommendations Pigging, Filtration
