# LPG PIPELINE REPAIR TECHNIQUES

AJAY PAL SINGH CM (P/L O&M)-JLPL LONI

Loni : 15 Dec, 2023

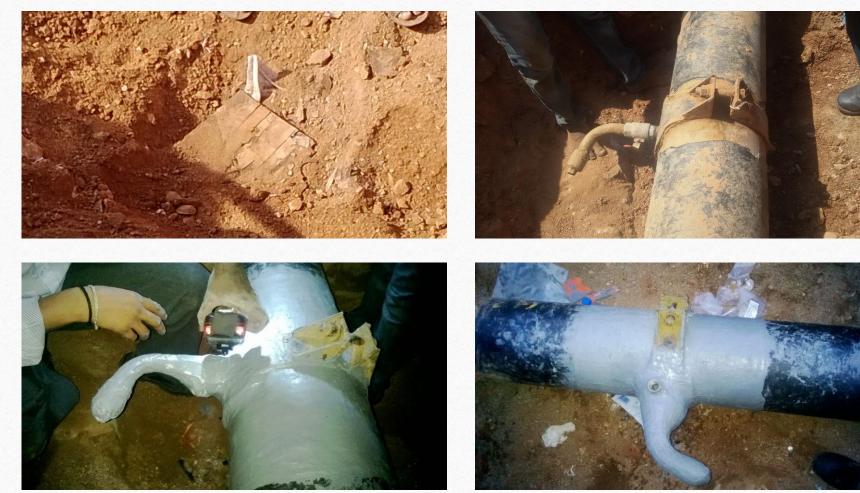
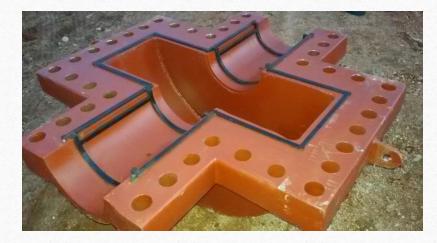
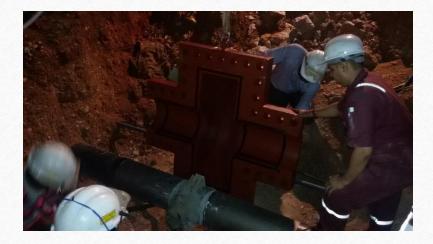
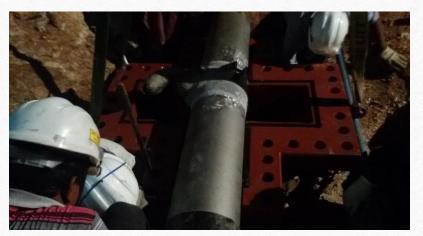
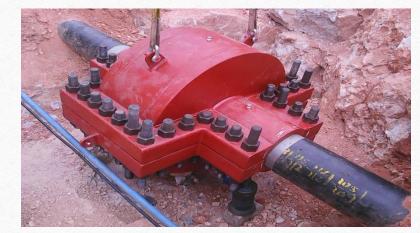
#### **CUSTOMISED MECHANICAL CLAMP USED IN VSPL CH. 485 KM**

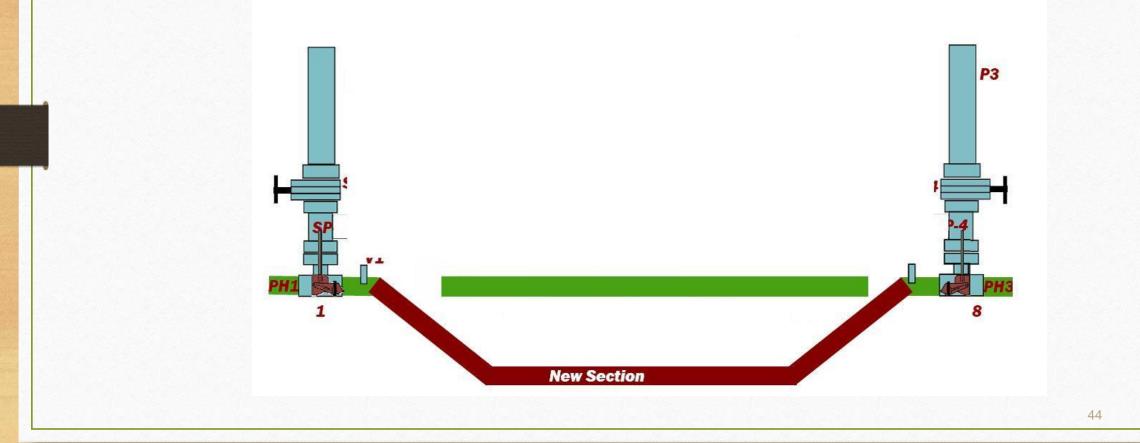
### PIPELINE REPLACEMENT AT HADAKIYA CREEK IN JLPL – INITIAL HOOK-UP SCHEME (SINGLE STOPPLE)

### **DISADVANTAGE OF INITIAL HOOK-UP SCHEME**

- Total shutdown of JLPL line for at least 72 Hrs there will be no flow between SV-08 to SV-09 section.
- Evacuation of approximately 125 MT LPG from the old section was required which was a very challenging job and an environmental issue.

- Recovery of LPG was possible only if some external arrangement was made like High pressure centrifugal pump, LPG tanker and other associated work.
- Remaining LPG of old line to be removed by cold / hot flaring through mobile flare before cutting and welding for hook up of new line with old line.

- Some major safety issues were also cause of concern. Cold flaring of LPG vapor in open atmosphere was extremely risky due to adjacent highway, nearby villages, etc..

- Apart from the operational / safety issues, financial issues were also involved. Total cost of LPG to be flared was approximately 53 lacs. It was not sure how much LPG out of total qty. of 125 MT could be evacuated before starting of Hook-up activity.

- Jamnagar to Samakhiali pipeline section would have been under shut down for at least 72 Hrs. resulting revenue loss of approximately Rs. 1.60 Crore.

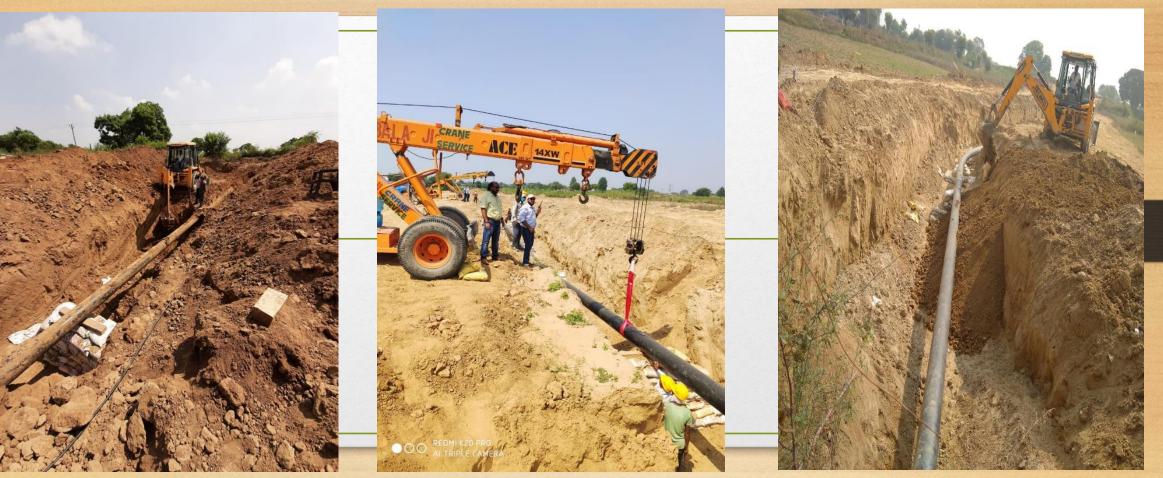
# LOWERING OF 12" DIA IN-SERVICE LPG P/L AT CH. 1169.25 KM NEAR RT-LONI

P/L Position before Lowering

**Lowering under progress**

**Position after Lowering**
