PIPELINE INTEGRITY FOR HIGH CONSEQUENCE AREAS: A CASE STUDY FOR MANAGING URBAN INFRASTRUCTURE

3RD CGD O&M WORKSHOP

Bidyut B. Baniah, C. Eng.

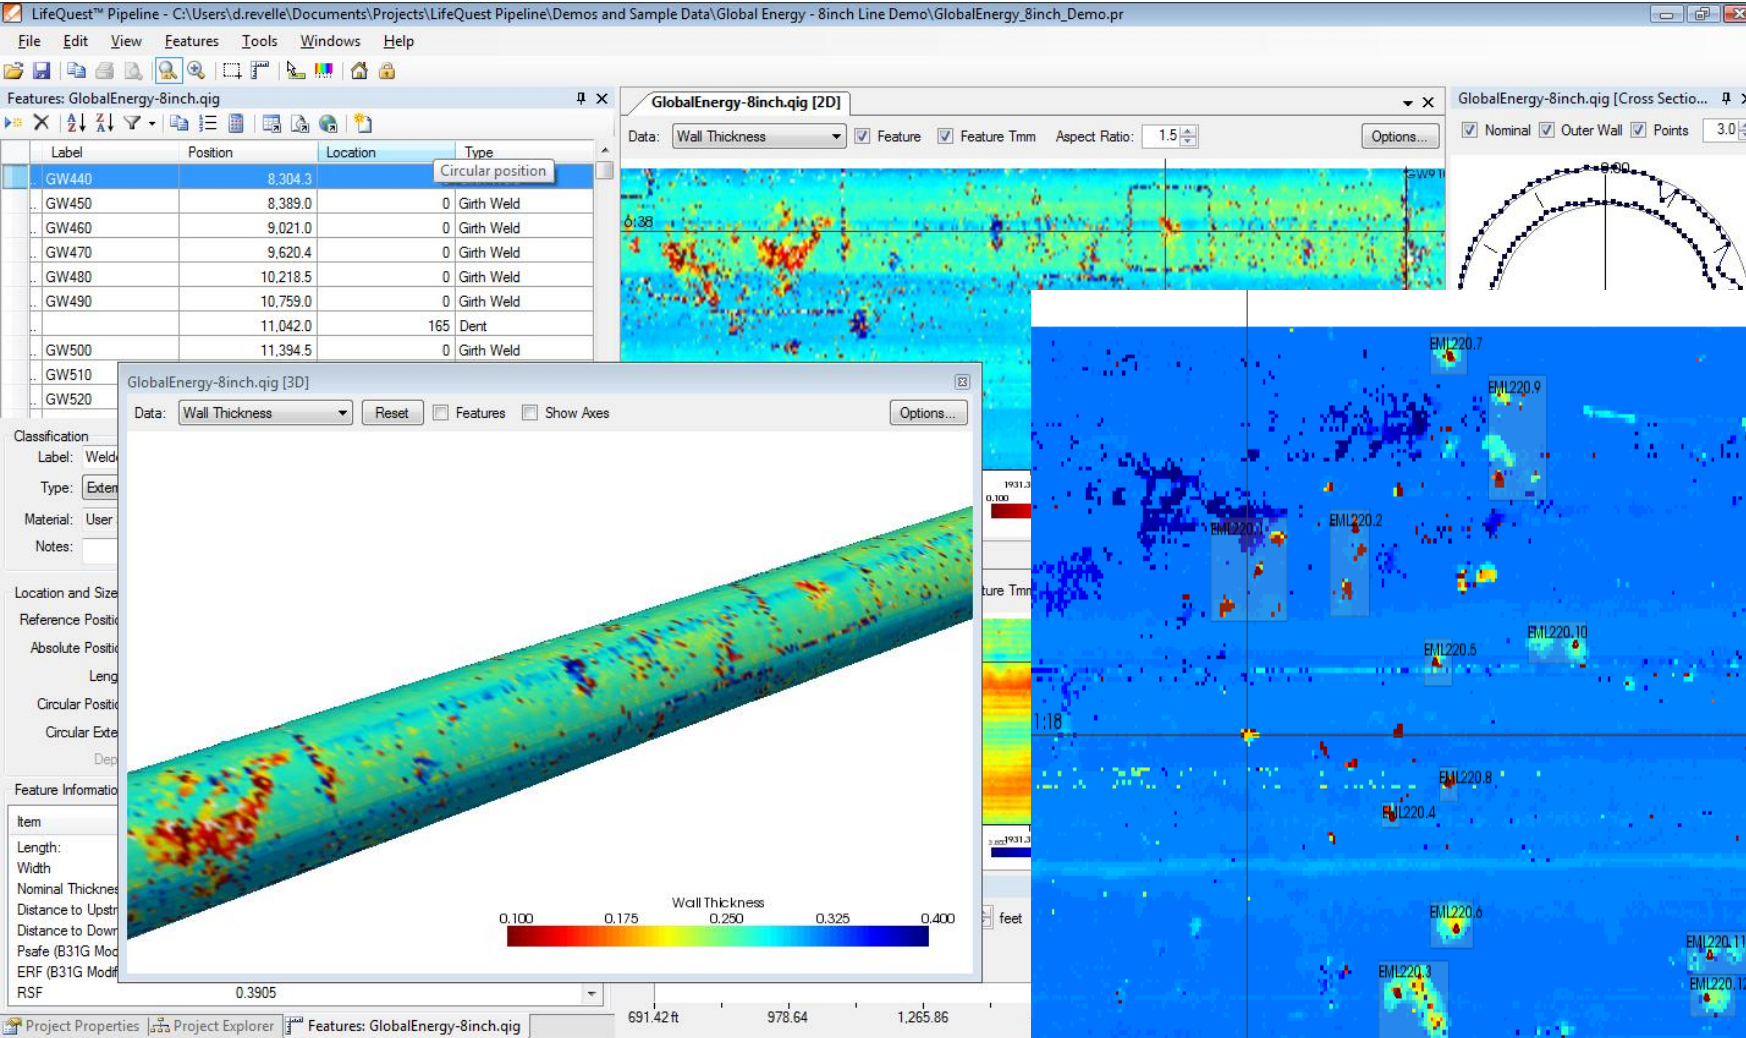
Pipeline Dent and its orientation

- Internal & external metal loss (worst reported was 58.6% wall loss)
- Dents (worst reported 5.5% of pipe OD)
- Mill and/or non-time dependent mechanical defects were also measured by the UT-ILI tool
- Because inspection was conducted with a high resolution UT-ILI tool, a confirmation of the “fit for service” (FFS) as per API 579 Level-II certificate was provided all four (4) pipelines inspected (complete length vs limited locations). It is to be noted that proper API 579 Level-II assessment cannot be conducted based on indirect inspection (MFL-ILI technology) data
- Although all four (4) pipelines had similar service and were in the same right-of-way, there were not in equivalent condition. Based on the UT-ILI data, two (2) of the four (4) were confirmed to have little or no integrity threats. Therefore, a blanket assumption cannot be made for pipelines – similar to a human body!

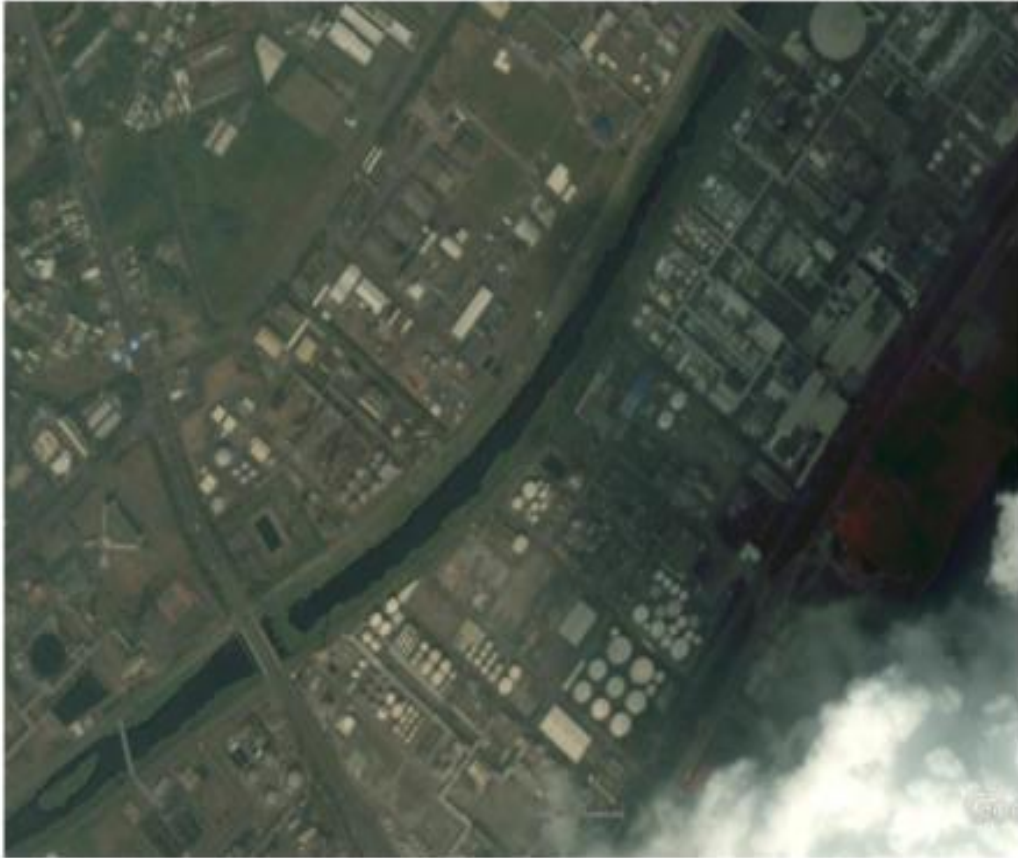
2003

The Effect of Urbanization in High Consequence Area (Urban Areas) – A GeoSpatial Overview of the inspected pipelines RoW in Kaohsiung, Taiwan
