# **INDRAPRASTHA GAS LIMITED**

## **CASE STUDY**

**Third Party Damage to Gas Pipeline and Fire  
/Explosion inside the House  
in GHAZIABAD**

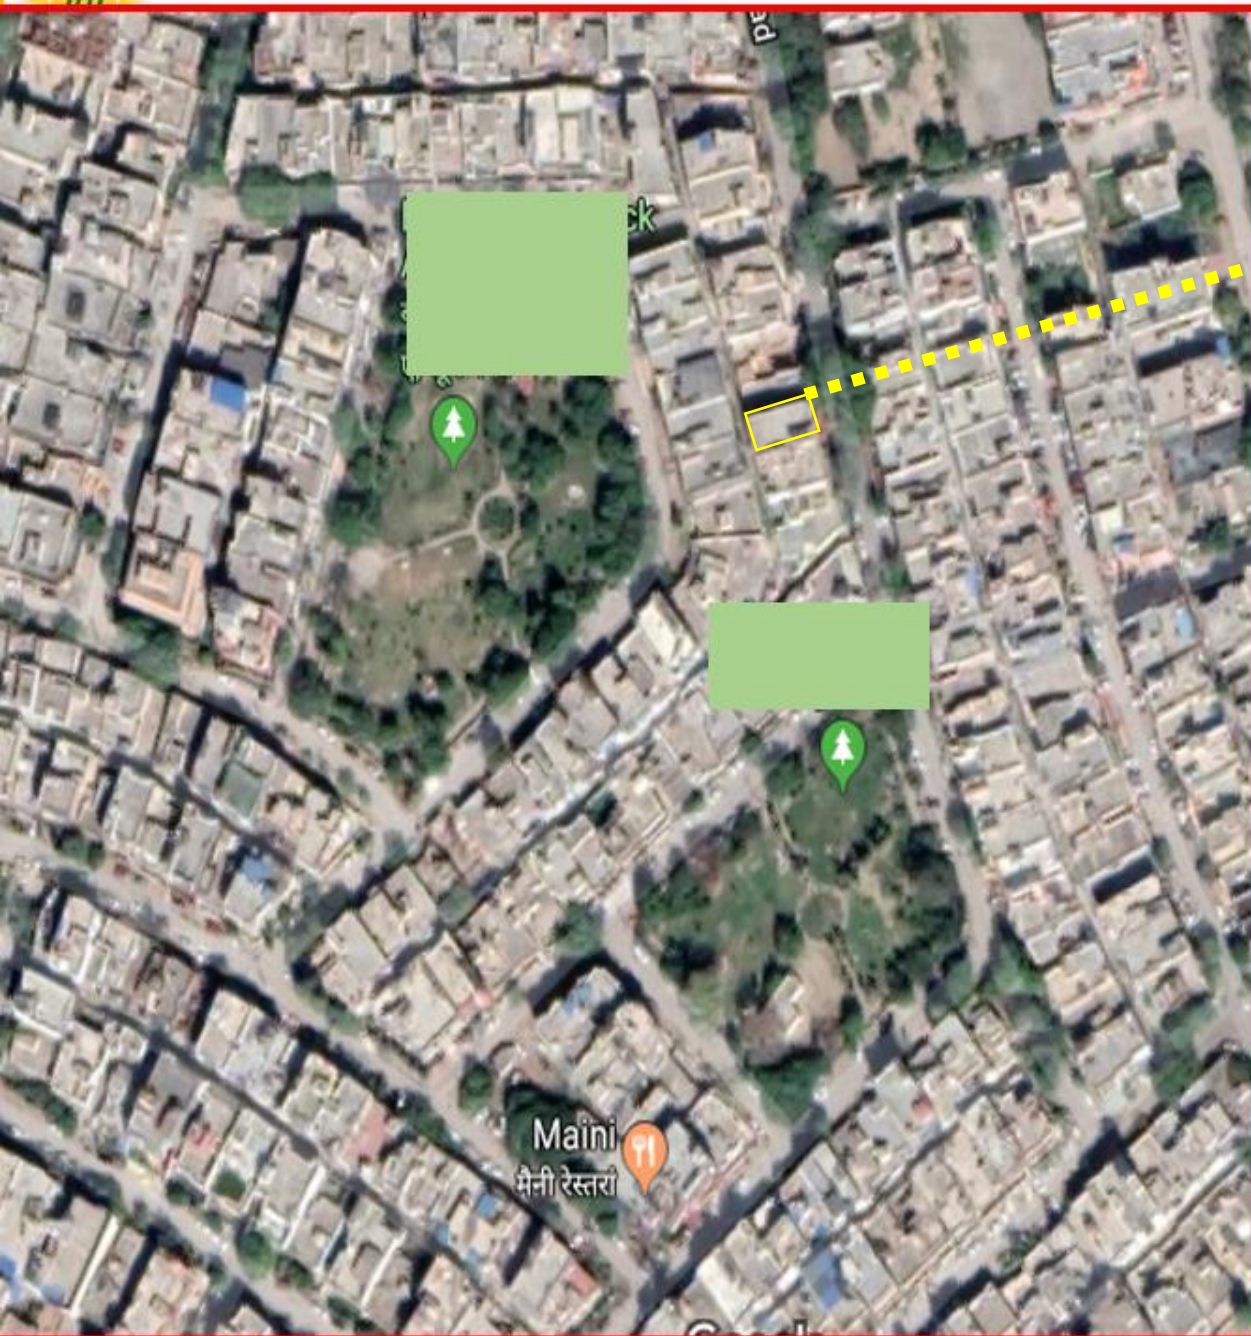
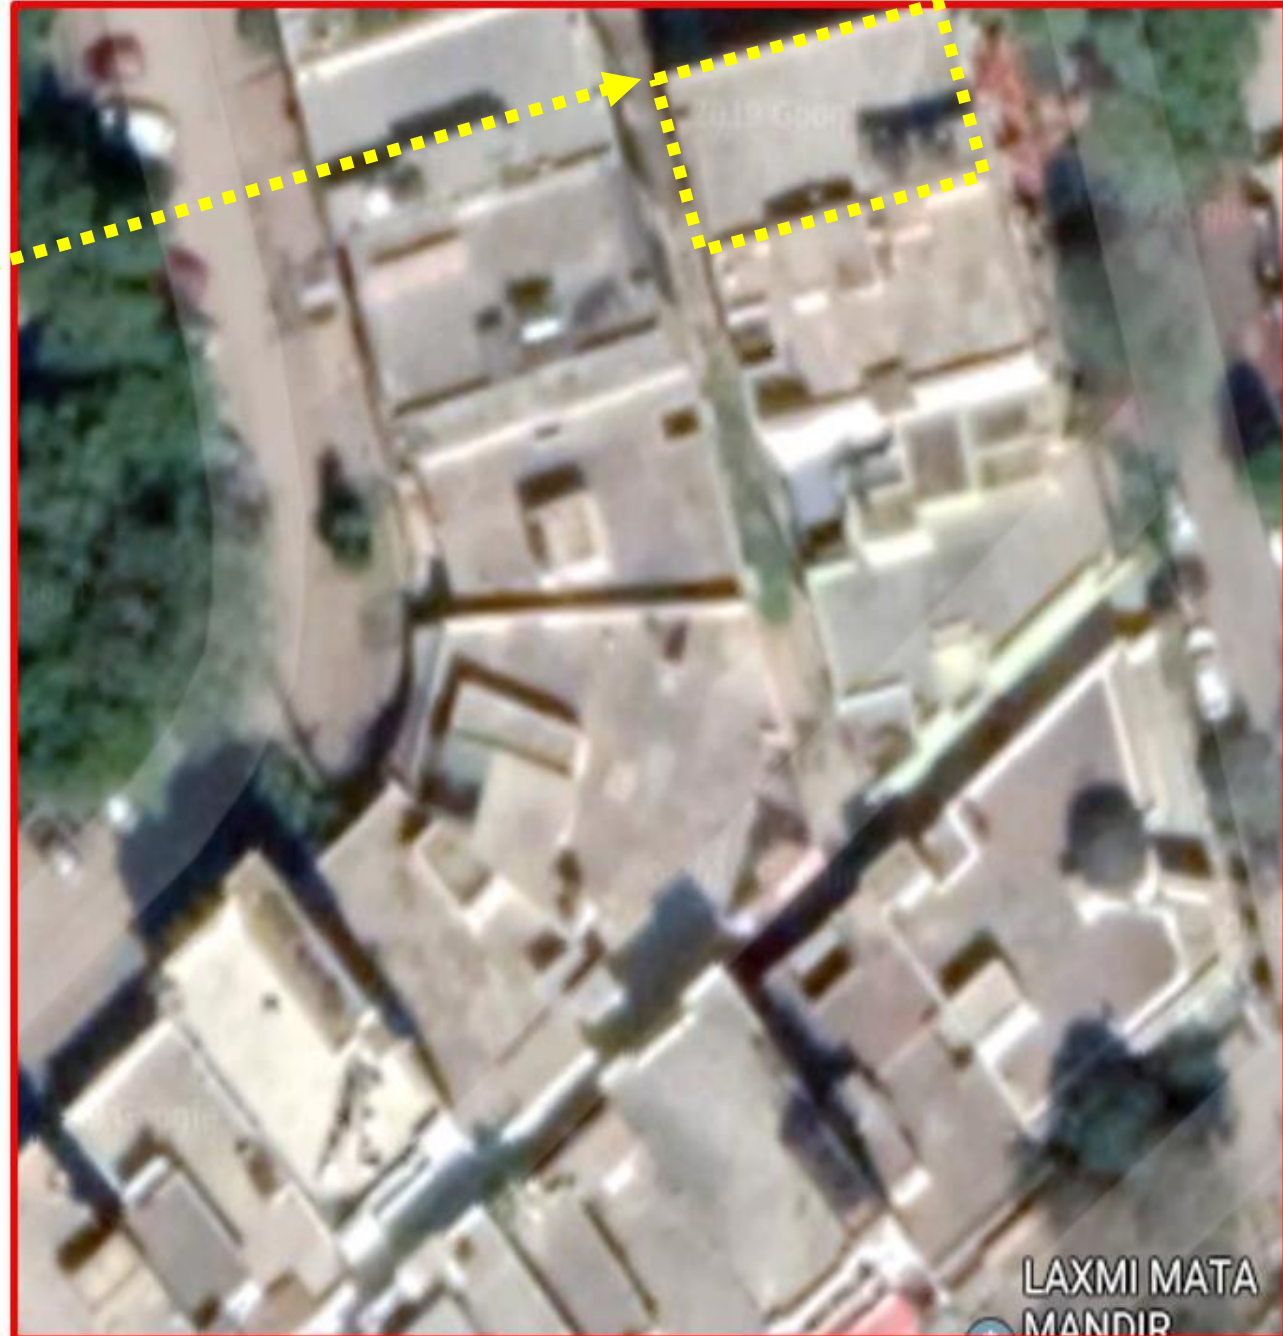
## FLOOR PLAN

32 mm dia MDPE  
pipeline  
Laid underground in  
the back lane  
Pressure ~ 4 bar(g)
