Steel Pipeline Experience in MGL

08.01.2019

Case Study -Black Powder in Gas Pipeline Network

Case Study -Valve Failure

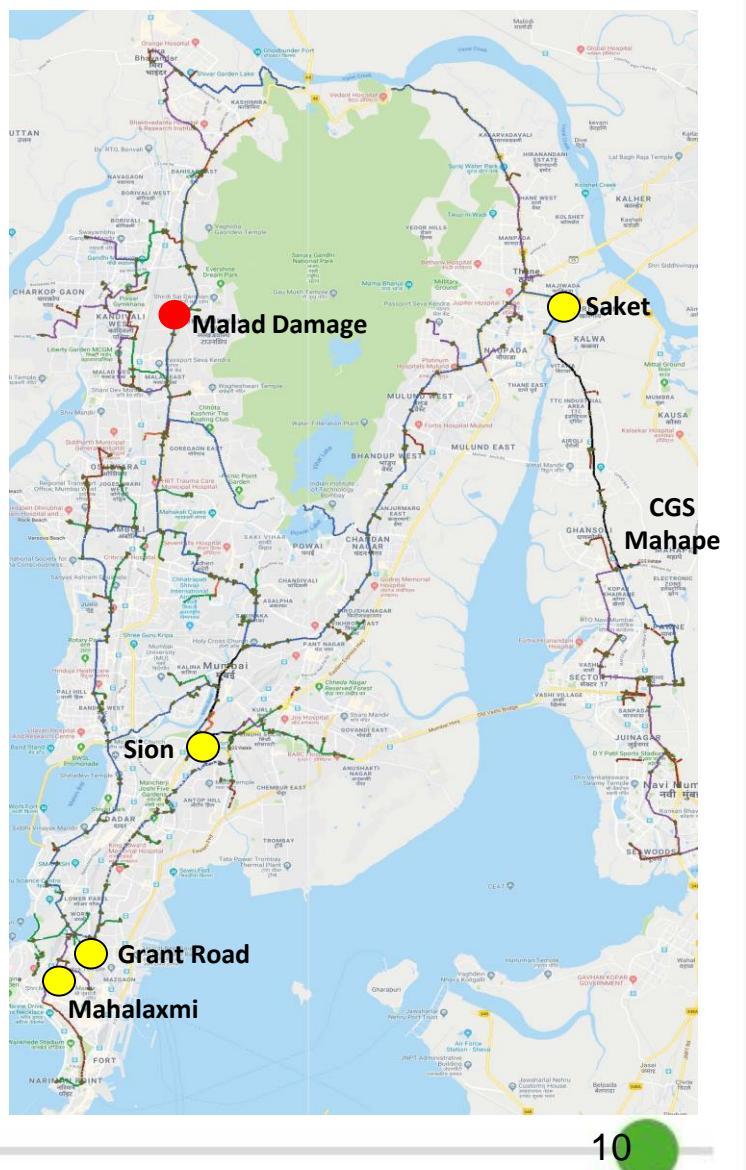
Trace of Black Powder in P/L Diversion

Location	Pipe size	Thick	Pipeline Cover	Year of P/L construction	Month & Year	BP Exists?
Botanical Garden, Sion	18" NB	8.2 mm	1.2 m	1998-1999	May'18	No
Botanical garden, Sion	12" NB	9.5 mm	1.2 m	1998-1999	Apr'18	No
Saket kalwa, Thane	12" NB	9.5 mm	2.0 m	2004-2005	Jun'18	No
Grant Road Metro Stn.	8″ NB	8.2 mm	1.3 m	2001-2002	Aug'18	No
Mahalaxmi Metro Stn.	8″ NB	8.1 mm	1.4 m	2001-2002	Sep'18	No
