Steel NG Pipeline Repair due to External Damage

Case Study : 4'' Pipeline Damage

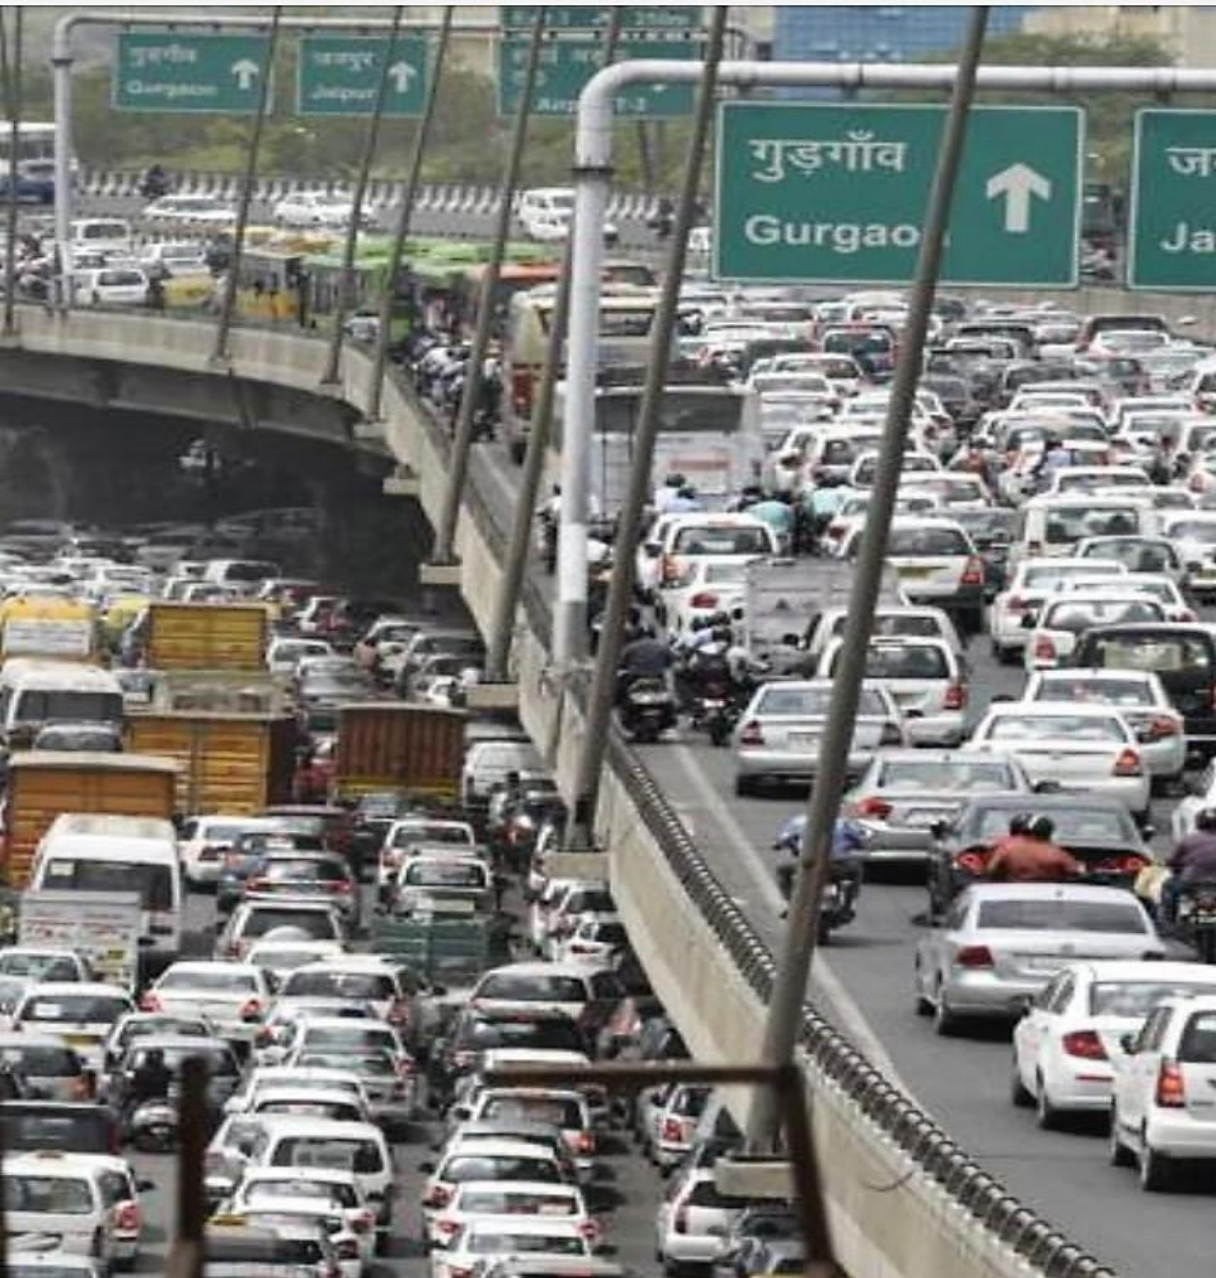
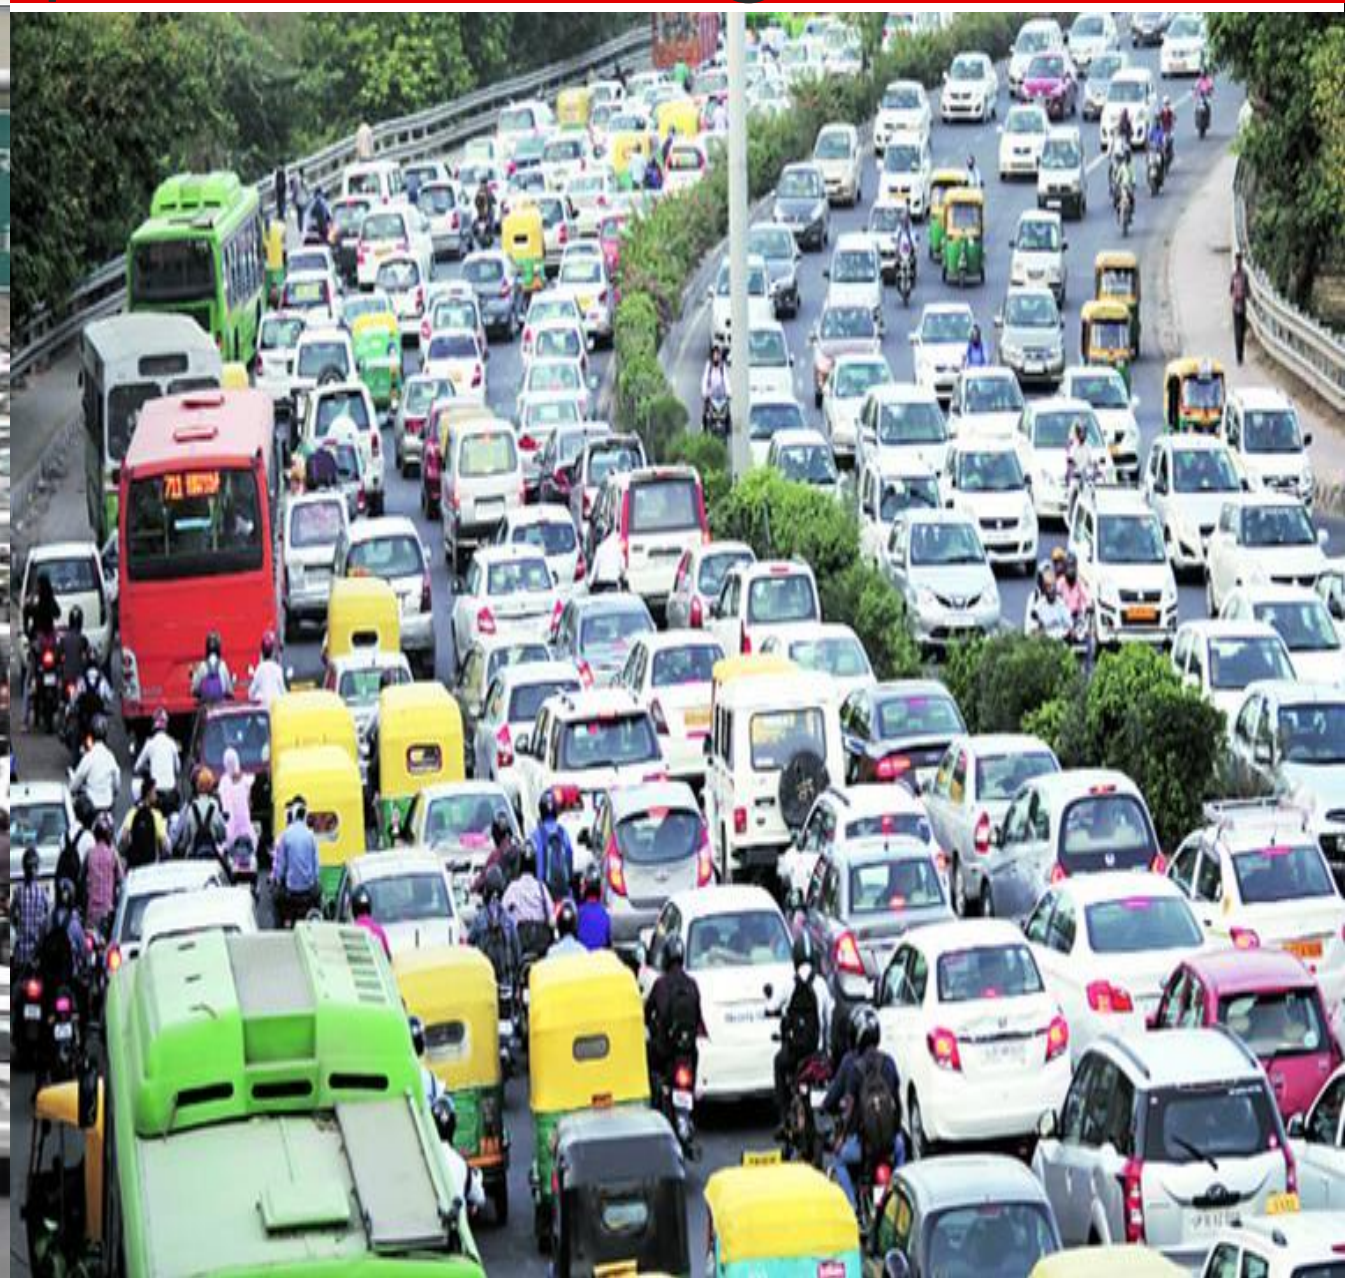
Case Study : BACKGROUND

- Patroller see the reamer on Delhi airport road informed about all safety precaution activity i.e. pipeline locating and permission
- Work stopped and control room informed

- Heavy leakage reported
- Pilot and reamer located
- Leakage from 2.5 mm patch observed
- On interrogation it was found that about 100 meter pipeline is damaged.

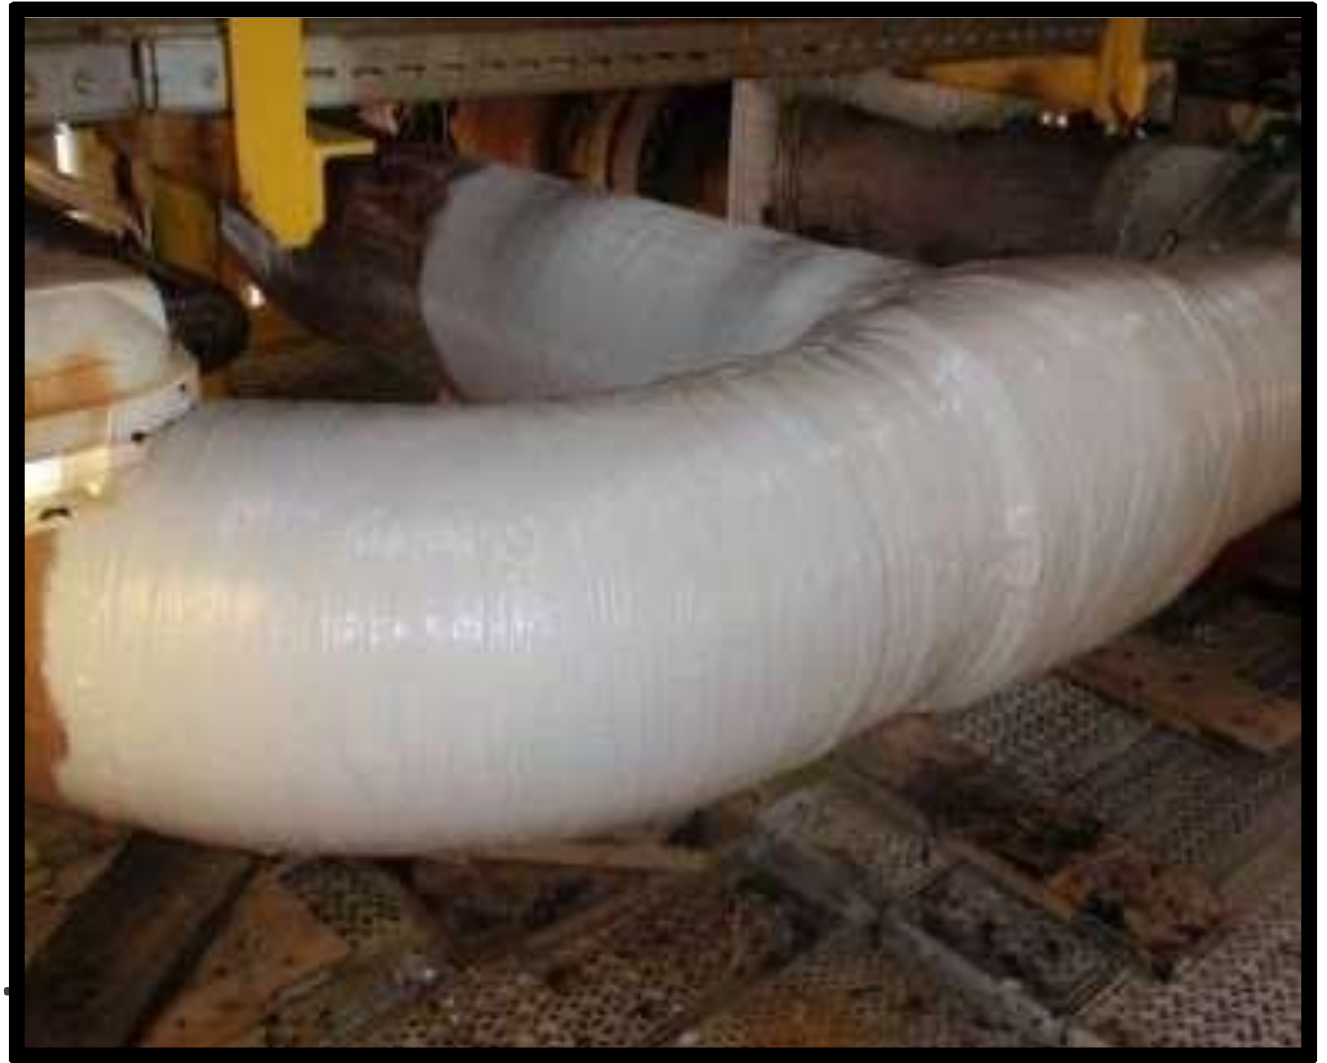
- ✓ The damage caused to the pipeline was severe and shape was distorted, extra care was taken at the time of filler application
- ✓ Protection of R4D repair was crucial before curing, as the site was on highway with high probability of trespassing

- ✓ The above repair is in accordance with ISO/TS 24817 and with the defect specification provided by IGL

The installation of R4D was satisfactory and was in accordance with 3X Engineering approved installation procedure
