Safety & Integrity Practices in MGL

MGL – an Overview

- Mahanagar Gas Limited (MGL) is a leading Piped Natural Gas Distribution company in India, currently operating in Mumbai & surrounding areas.
- A Joint Venture of GAIL, BG (UK) & Govt of Maharashtra, set up in 1995.
- MGL has till date laid a network of 389 Km of Steel & 3865 km of PE (MP & LP) pipelines covering a domestic potential of more than 1 million customers.
- ISO 9001, 14001 & OHSAS 18001 Certified.
- Safe & Successful 18 years of business so far.

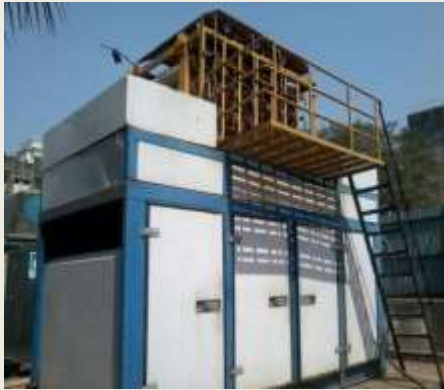
Compressor – Design features

- Design conforms to international standards - API 618/ / API 11P.
- Electrical devices, control panel, instruments suitable for hazardous area classification Zone 1 (as per IS 5572), Flameproof electrical fittings
- Pressure transmitters / switches for automatic shut down of compressor in case of process deviation..
- Provision of GD / FD inside canopy.
- Complying PESO guideline
- ESD at three places – Compressor, Dispenser and Sales office
- Provision of CO2 flooding system

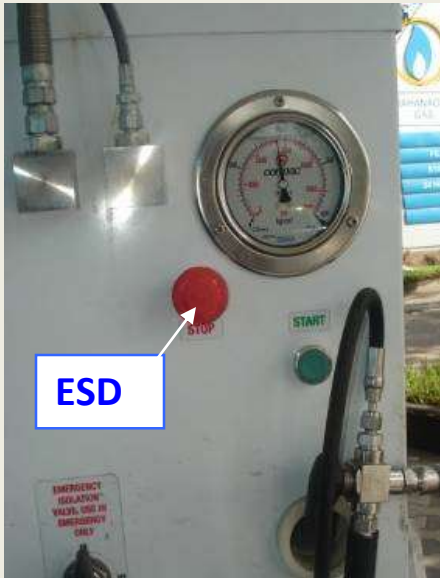
Dispenser – Safety features

- Brake away coupling on filling hose - to prevent leak if hose pull out occurs
- Filling hoses are electrically conductive to avoid any static charge
- ESD at Dispenser
- Trained filler men equipped with adequate PPEs
- “No Metal plate - No Gas” strictly being followed.
- Dispenser Operator check metal plate for.....
 - Metal plate is clearly visible
 - There is no any correction / overwrite.
 - Vehicle Number is same as mentioned in metal plate.
 - Test date and next due date of cylinder is available

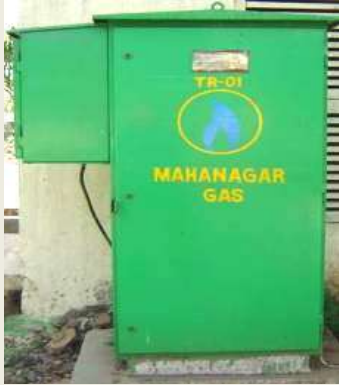
Steel Pipeline – Safety Features

- CP Monitoring through RMU system
- DCVG survey prior to pipeline commissioning
- Corrosion rate analysis thru –
 - Testing Opportunistic Coupon @ IIT
 - ER Probes – on quarterly basis
- CP Parameters monitoring through RMU

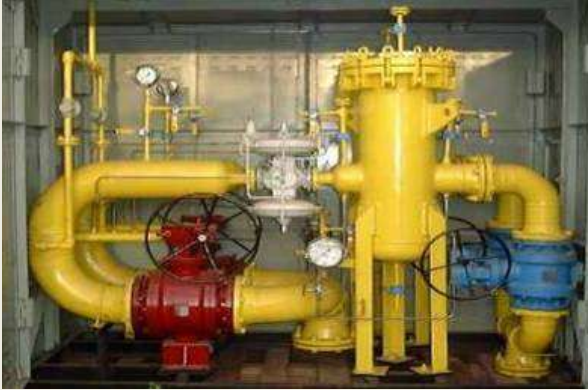
DRS – Design features

- Twin Stream – 100% Redundancy.
- Active + Monitor Regulator in each stream
- SSV + SRV for over pressure shut off
- Auto switch-over incase of one stream malfunction
- Data logger in each DRS to monitor operating parameters

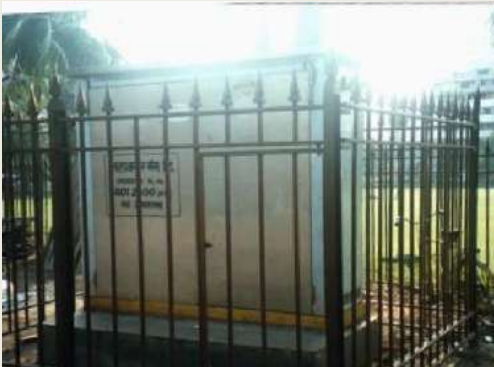
DRS – Safety features

- Maintenance – once in a year
- Risk audit of each DRS installation
- DRS network in loop

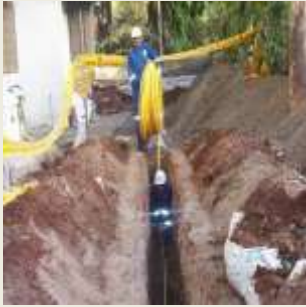
PE Pipeline - Design features

- Laid with typically 1 meter top cover plus RCC tiles & warning tape
- Low pressure (100mbar) network inside residential premises
- PE pipe procured in coils to minimize number of joints
- Can be easily squeezed off for stopping gas supply during emergency
- Best method of PE jointing i.e., electrofusion fittings are used

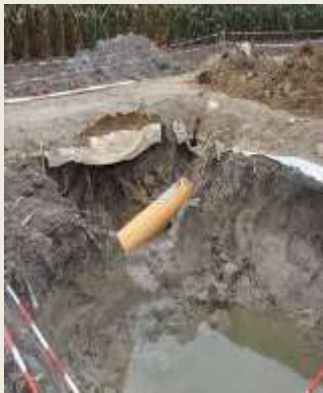
PE Pipe – Safety features

- Extensive Patrolling - Twice in a day
- Use of GIS Software
 - 100% network mapped
 - Handheld devices with GIS system by patrolmen
- Use of VTS for effective monitoring of patrolling activity.
- Leak detection survey – once in a year
- Coordination meetings with other utility
- Use of anti rodent HDPE sleeve bends to safeguard PE crimp from rodent bite

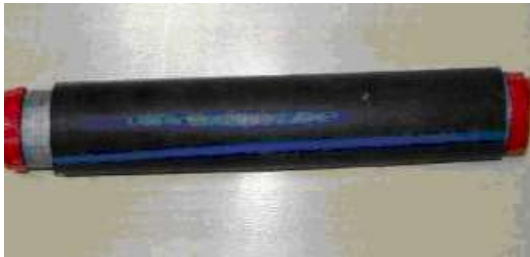
Pre Sleeved Hole Piece

- Powder coated pipe
- Welded joints in high rise building riser
- Use of Pre-sleeved hole piece for wall crossing
- Use of Aluminum clamps
- Installation - open to atmosphere
- Periodic maintenance of Riser pies.

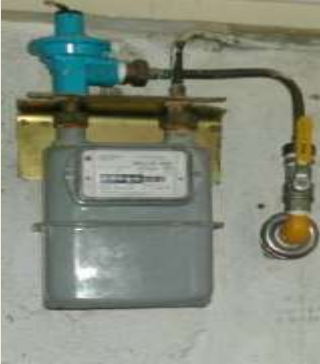
Domestic Meter Installation

- Meter Control Valve (MCV) at the entry point
- Meter installation in adequately ventilated area
- Preventive maintenance at regular intervals
 - Leak test

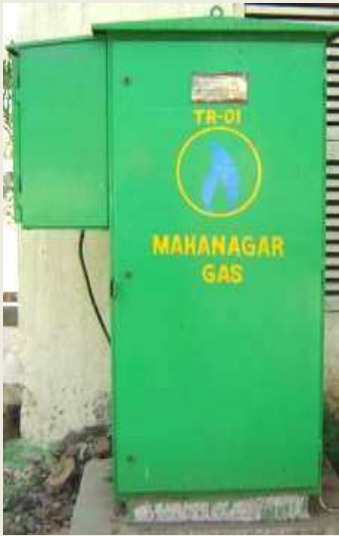
MGL CP System

- Temporary CP during construction stage, ICCP post commissioning.
- Remote Monitoring Unit (RMU) – Various data / information captured remotely
 - PSP, DC volt, AC volt, AC current
 - Various alarms – Under PSP, Over protection, All reference fail, TR unit door open etc.
- Diode Stations installed at Railway crossings to mitigate DC interference
- ER probes / corrosion coupons – ER probes to determine the corrosion rate and corrosion coupons to determine the ON and OFF PSPs
- DCVG survey – prior to commissioning to detect coating defect

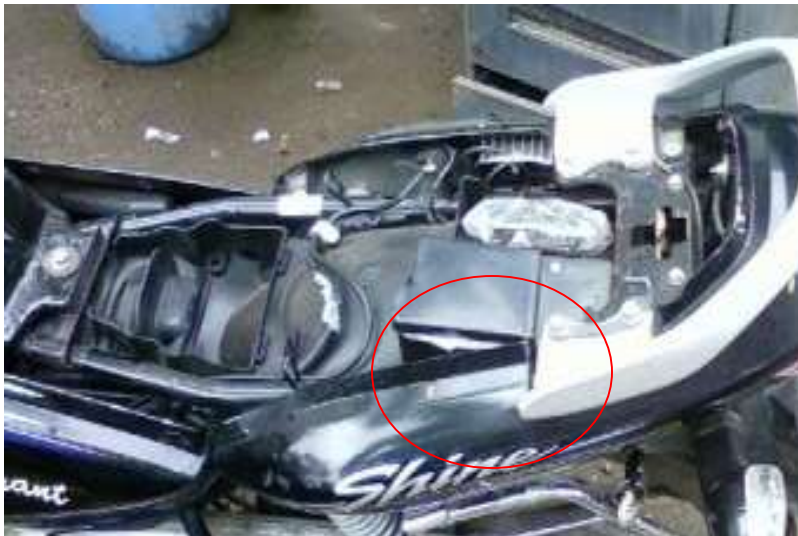
VTS installed on Patrolman's motor bike

- Ability to track Vehicles from Point to Point in real time
- Visual representation of the geographical location
- Real time two-way communication between the base, Operations and vehicles
- Ability to provide accurate network wide location information of the entire fleet
- Grouping of Vehicles by user

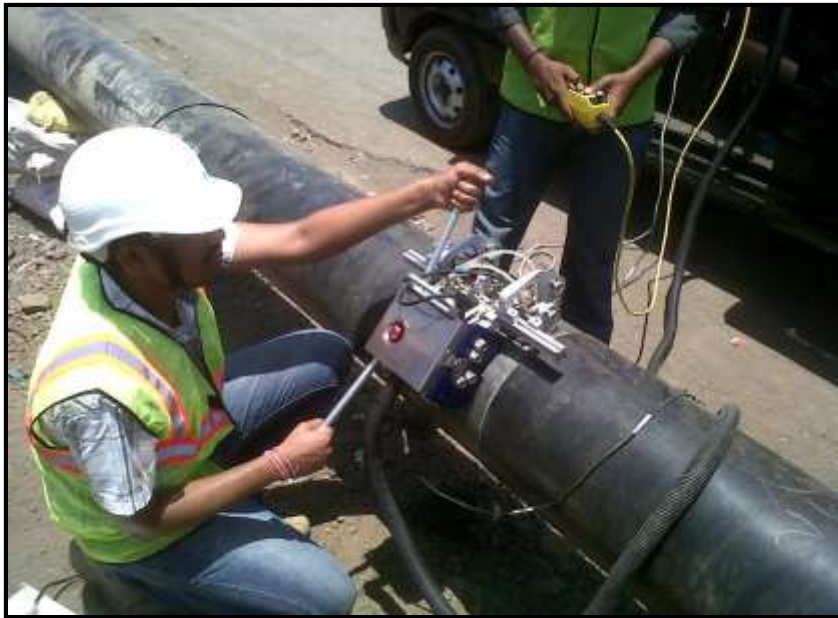
- Automated Ultrasonic Testing – NDT technique
- Used to check soundness of weld joints
- Alternative to Radiography to avoid radiation hazard

Performing AUT at site

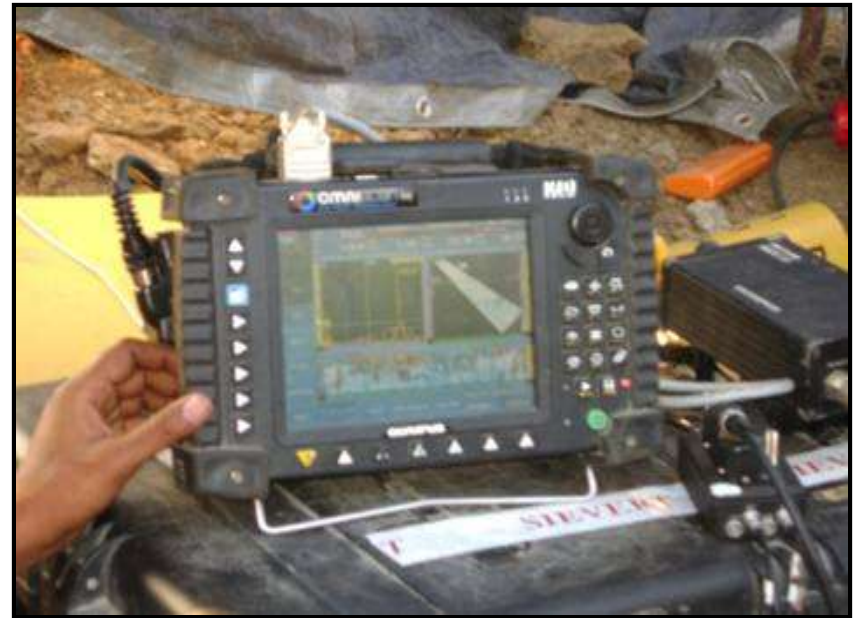
Results Interpretation

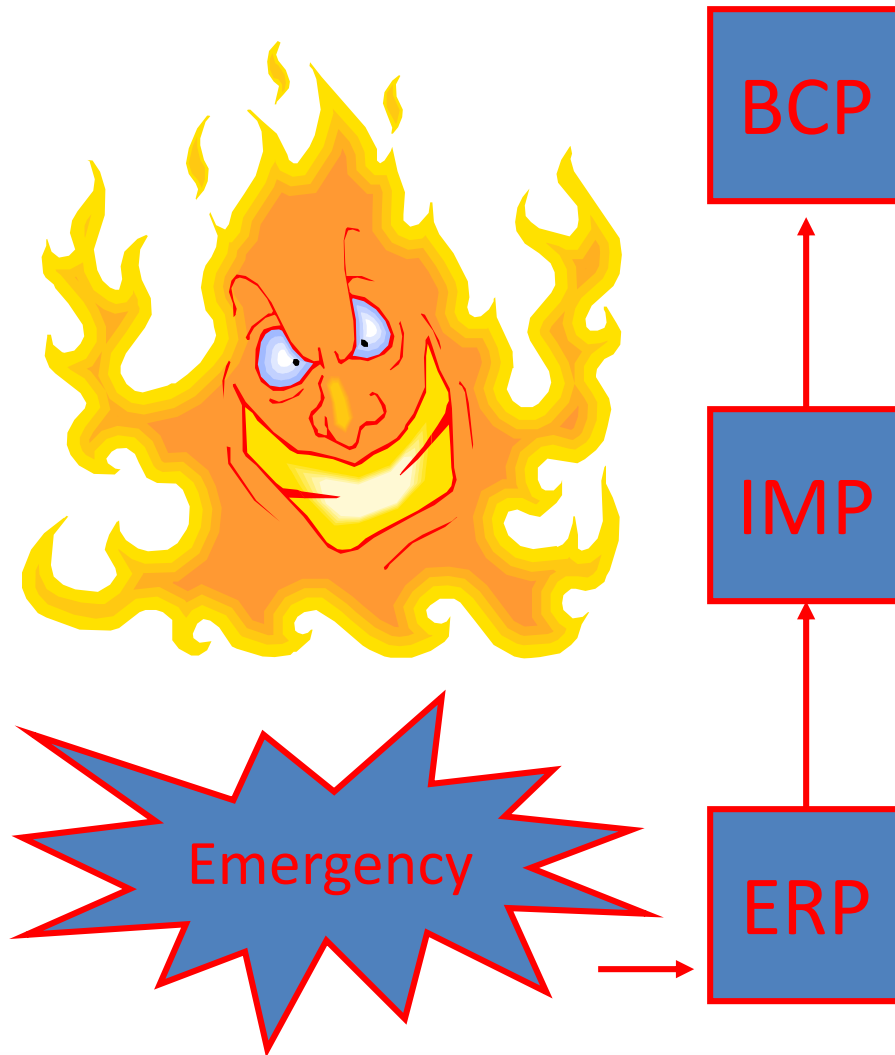
Emergency Response – Three Tier system

(3) Business Continuity Plan

Alternate arrangements to enable business continuity.

(2) Incident Management Plan

Manage & limit the impact on Business & surroundings.

(1) Emergency Response Plan

Immediate action to tackle the incident

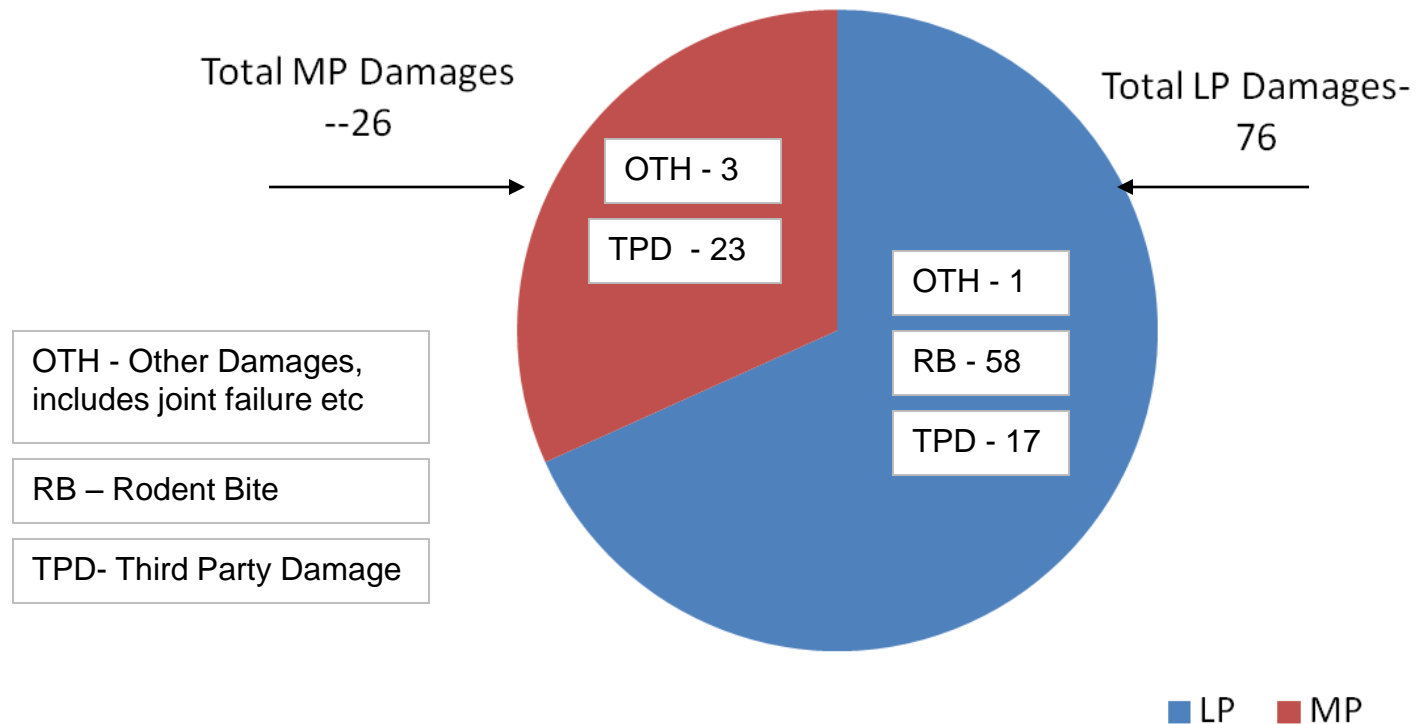
PE Damages July 2013 to June 2014

PE Damage statistics

- Third party damage is a major threat to gas network
- Third party Damages are generally less during off construction season.
- Lesser diameter of PE pipe (20, 32 mm) - more prone to damage.
- Rodent bite damage – occurs close to property on small diameter pipes.
- Number of PE Joint failures are very small.
- Not a single incident of steel pipeline failure due to corrosion

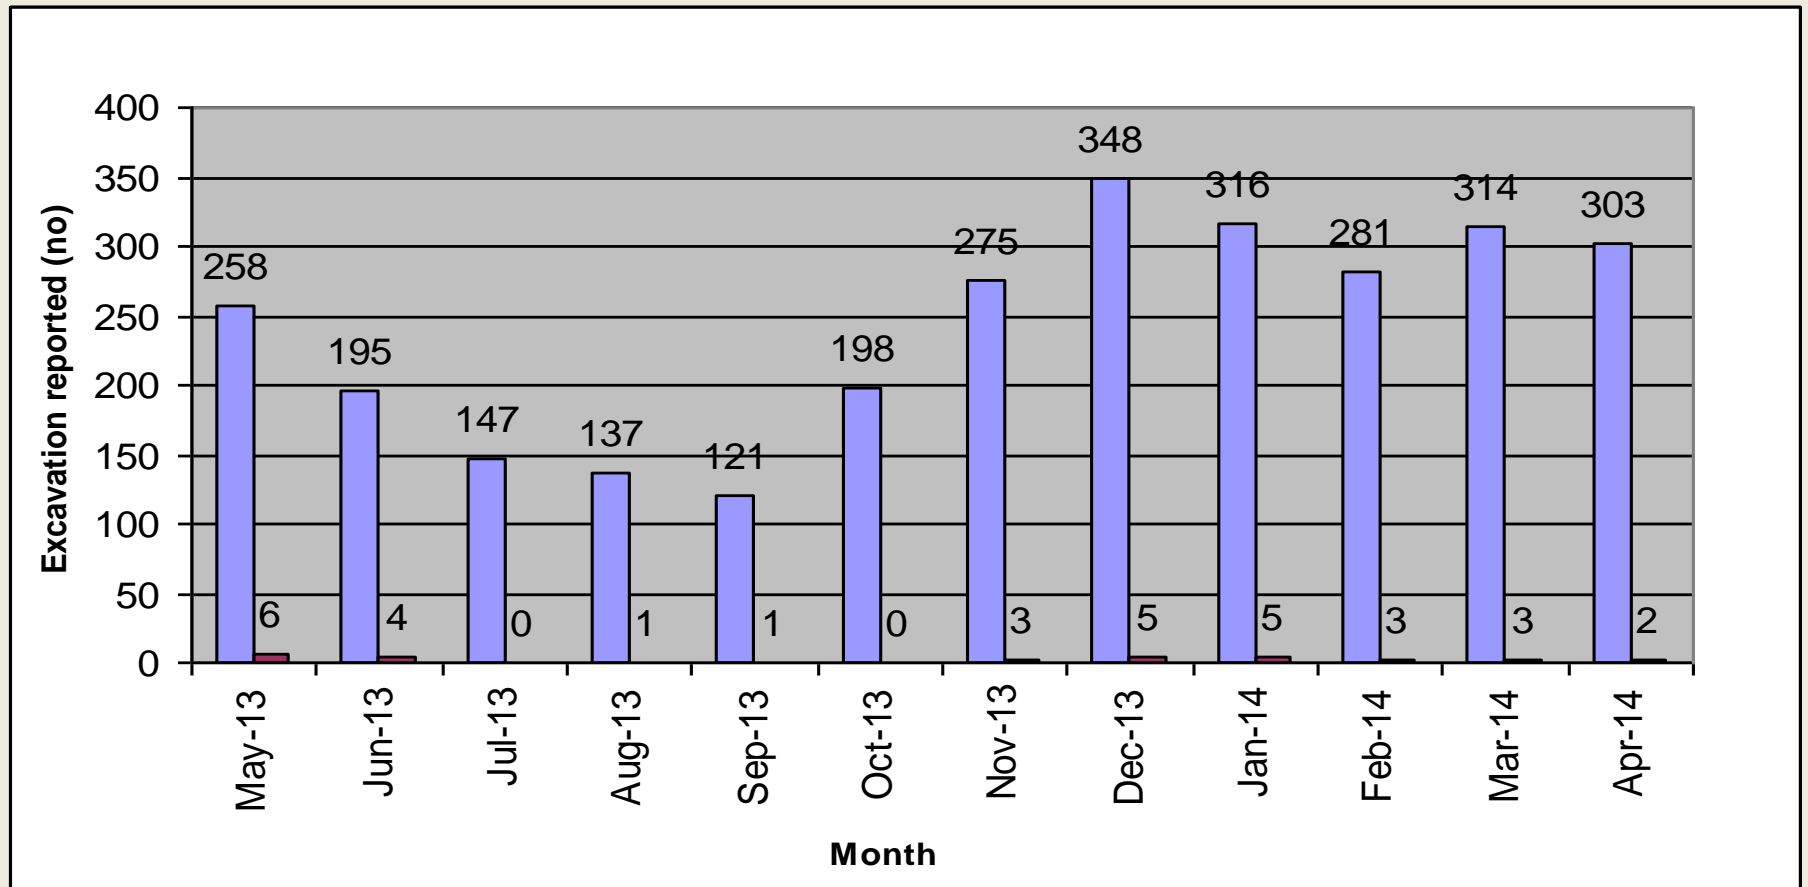
Comparison — Excavation reported v/s Third Party Damage

PE Damages Excavation reported v/s Third Party Damage

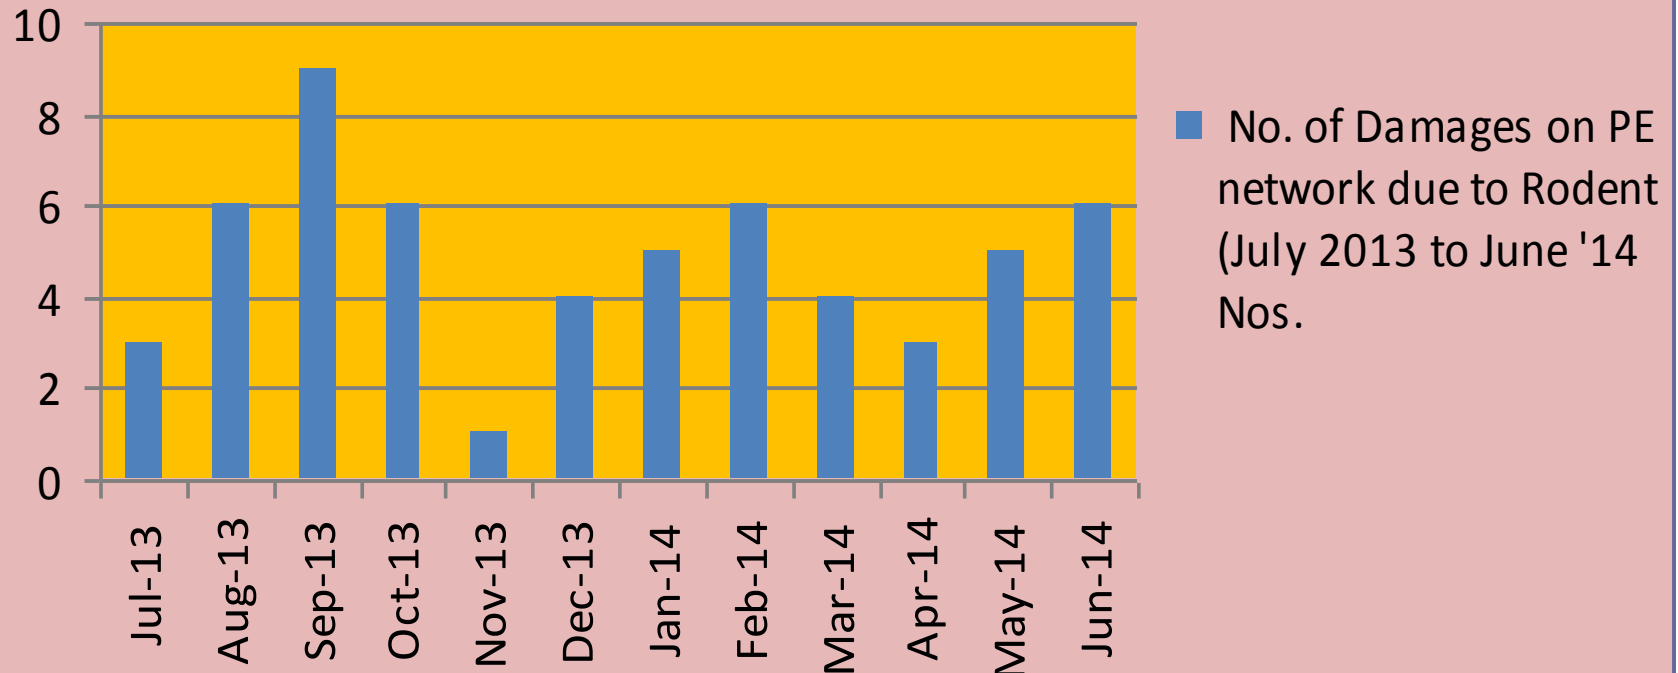
PE Damage due to rodent bite

No. of Damages on PE network due to Rodent (July 2013 to June 2014)
